FIGURE 2: RETROFIT SCHEME FOR McLEOD TOWER -- LOBBY

**Campus**      **Palomar Medical Center**

**Subject: Review of Engineering Geology and Seismology for  
Palomar Memorial Hospital - Escondido**  
555 East Valley Parkway, Escondido, San Diego County, CA 92025  
OSHDP file #1953-004-37

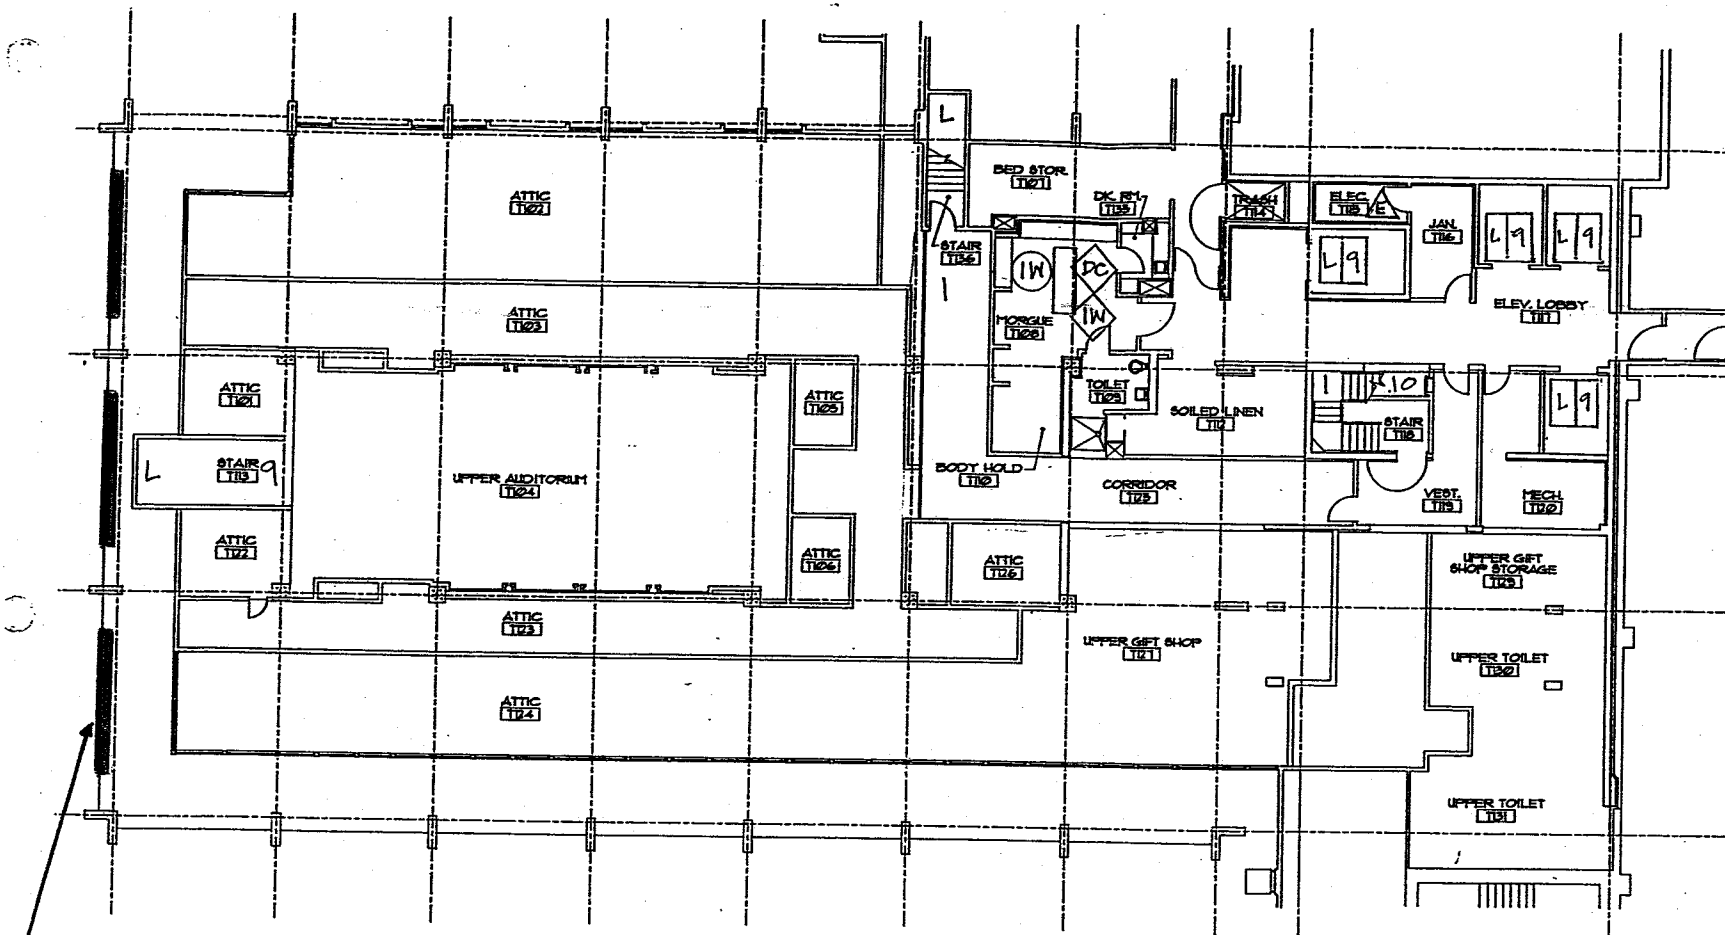
FIGURE 4

12" New Concrete  
 Shear Wall (typical)

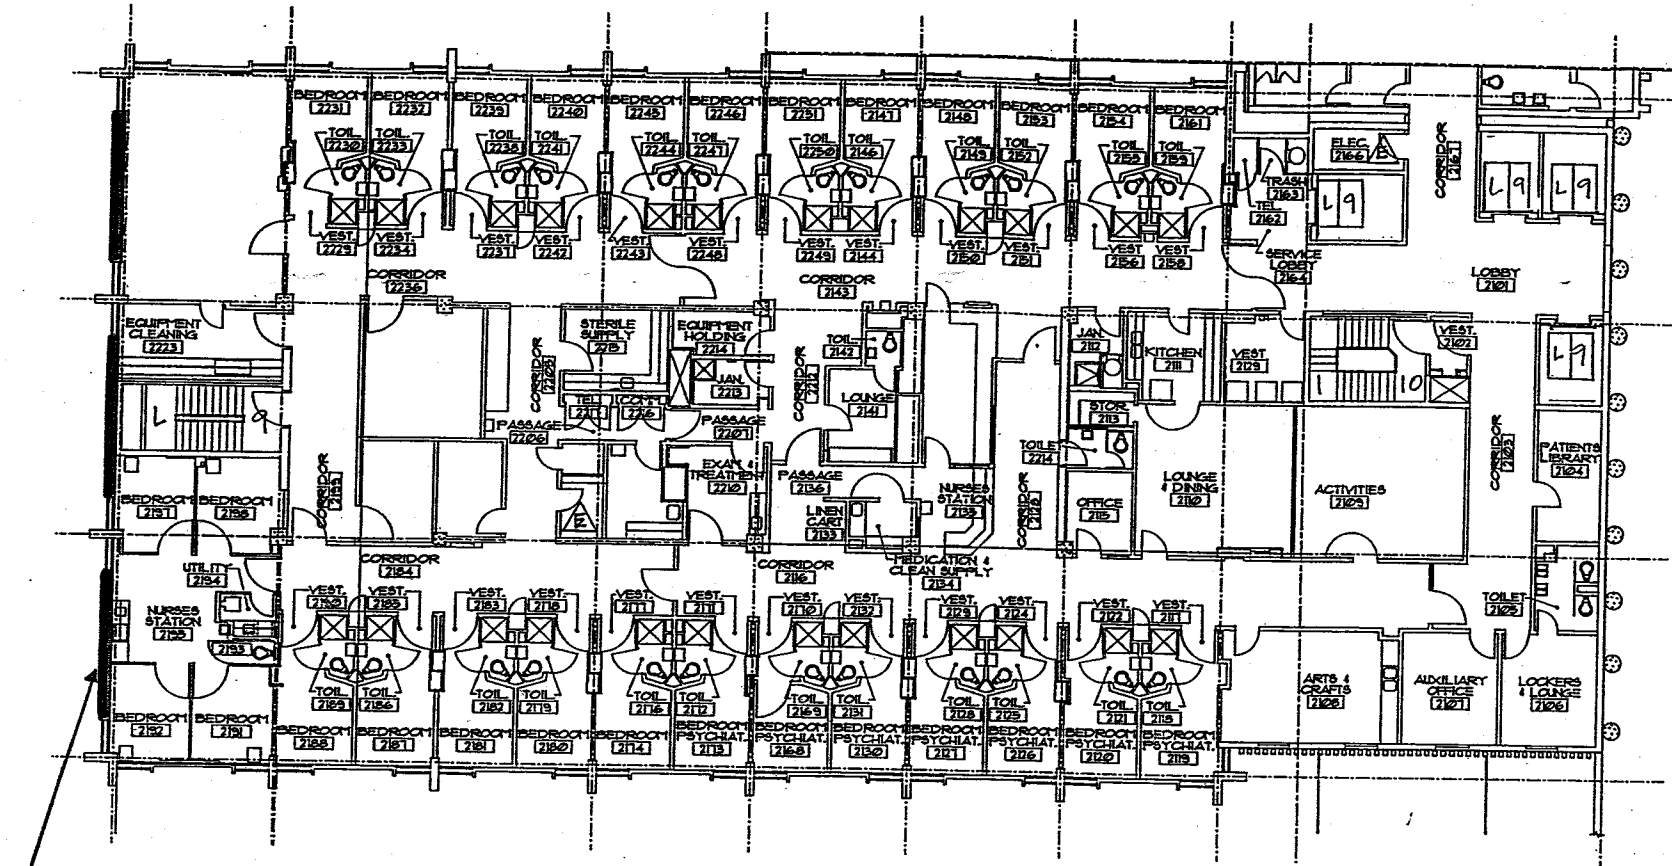
12" New Concrete  
 Shear Wall (typical)
