# **PALOMAR MEDICAL CENTER HAZUS UPDATE**

November 29, 2007

CO Architects  
KPF Consulting Engineers

PALOMAR  
POMERADO  
HEALTH

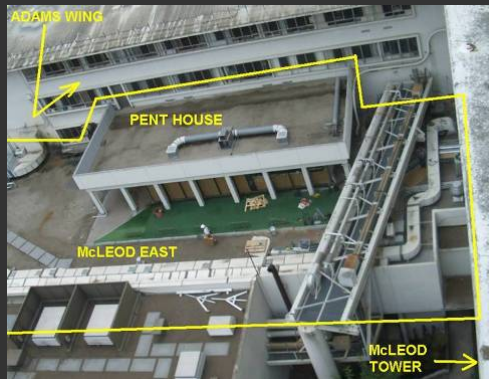
## McLeod East Penthouse

- The SPC Evaluation for McLeod East revealed that the building's penthouse may pose a local hazard due to a "weak column" deficiency.
- Does not pose a global collapse hazard, so we do not believe that it will affect the reclassification using HAZUS.
  - Need to confirm this assumption with OSHPD.
- KPFF recommends that the penthouse be removed or retrofitted to mitigate this hazard.
