PROPOSED PALOMAR MEDICAL CENTER WEST

GRADING REPORT

December 2005

**REVIEW OF GRADING FILLS at the
PROPOSED PALOMAR WEST MEDICAL CENTER SITE
(also referred to as the ERTC Site)**

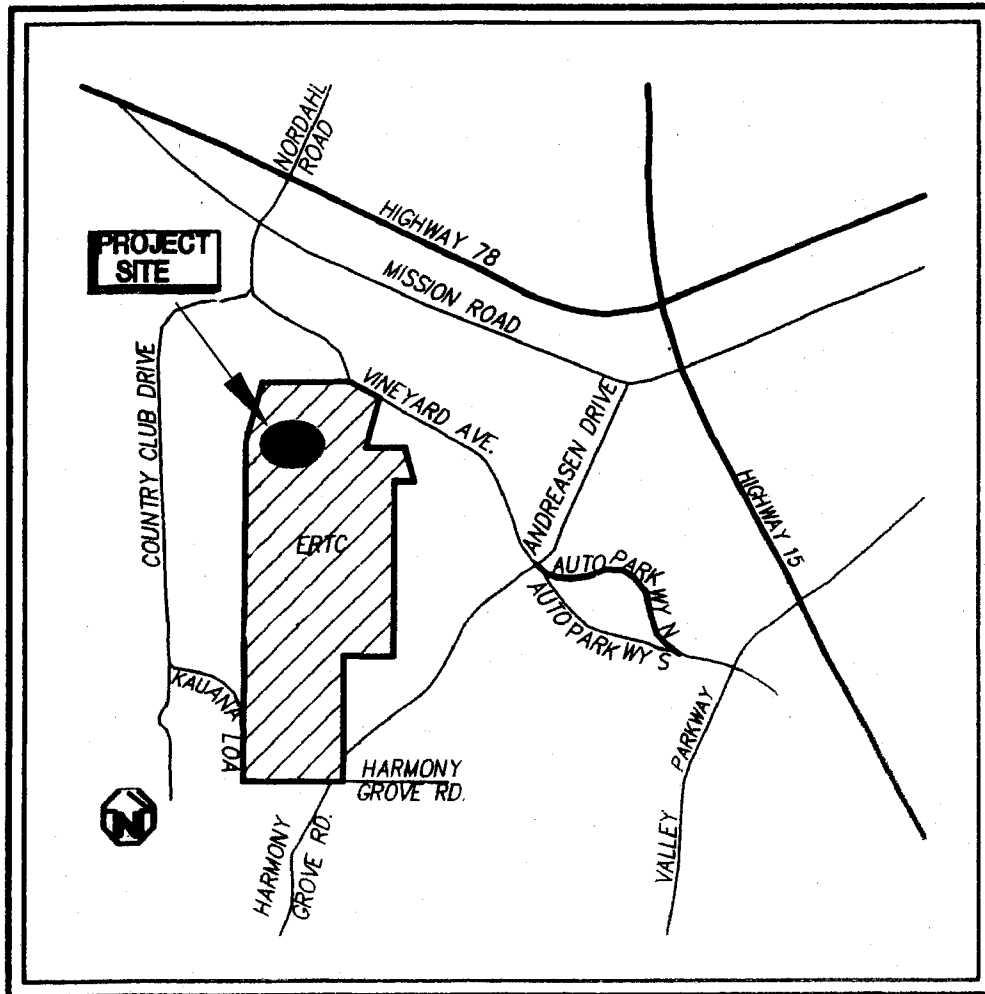
Figure No. 1
Job No. 04-8585

VICINITY MAP

Parcel 2,3 and 7
ERTC Project
Escondido, CA.

Vicinity Map By
McArdle Associates
Architects.

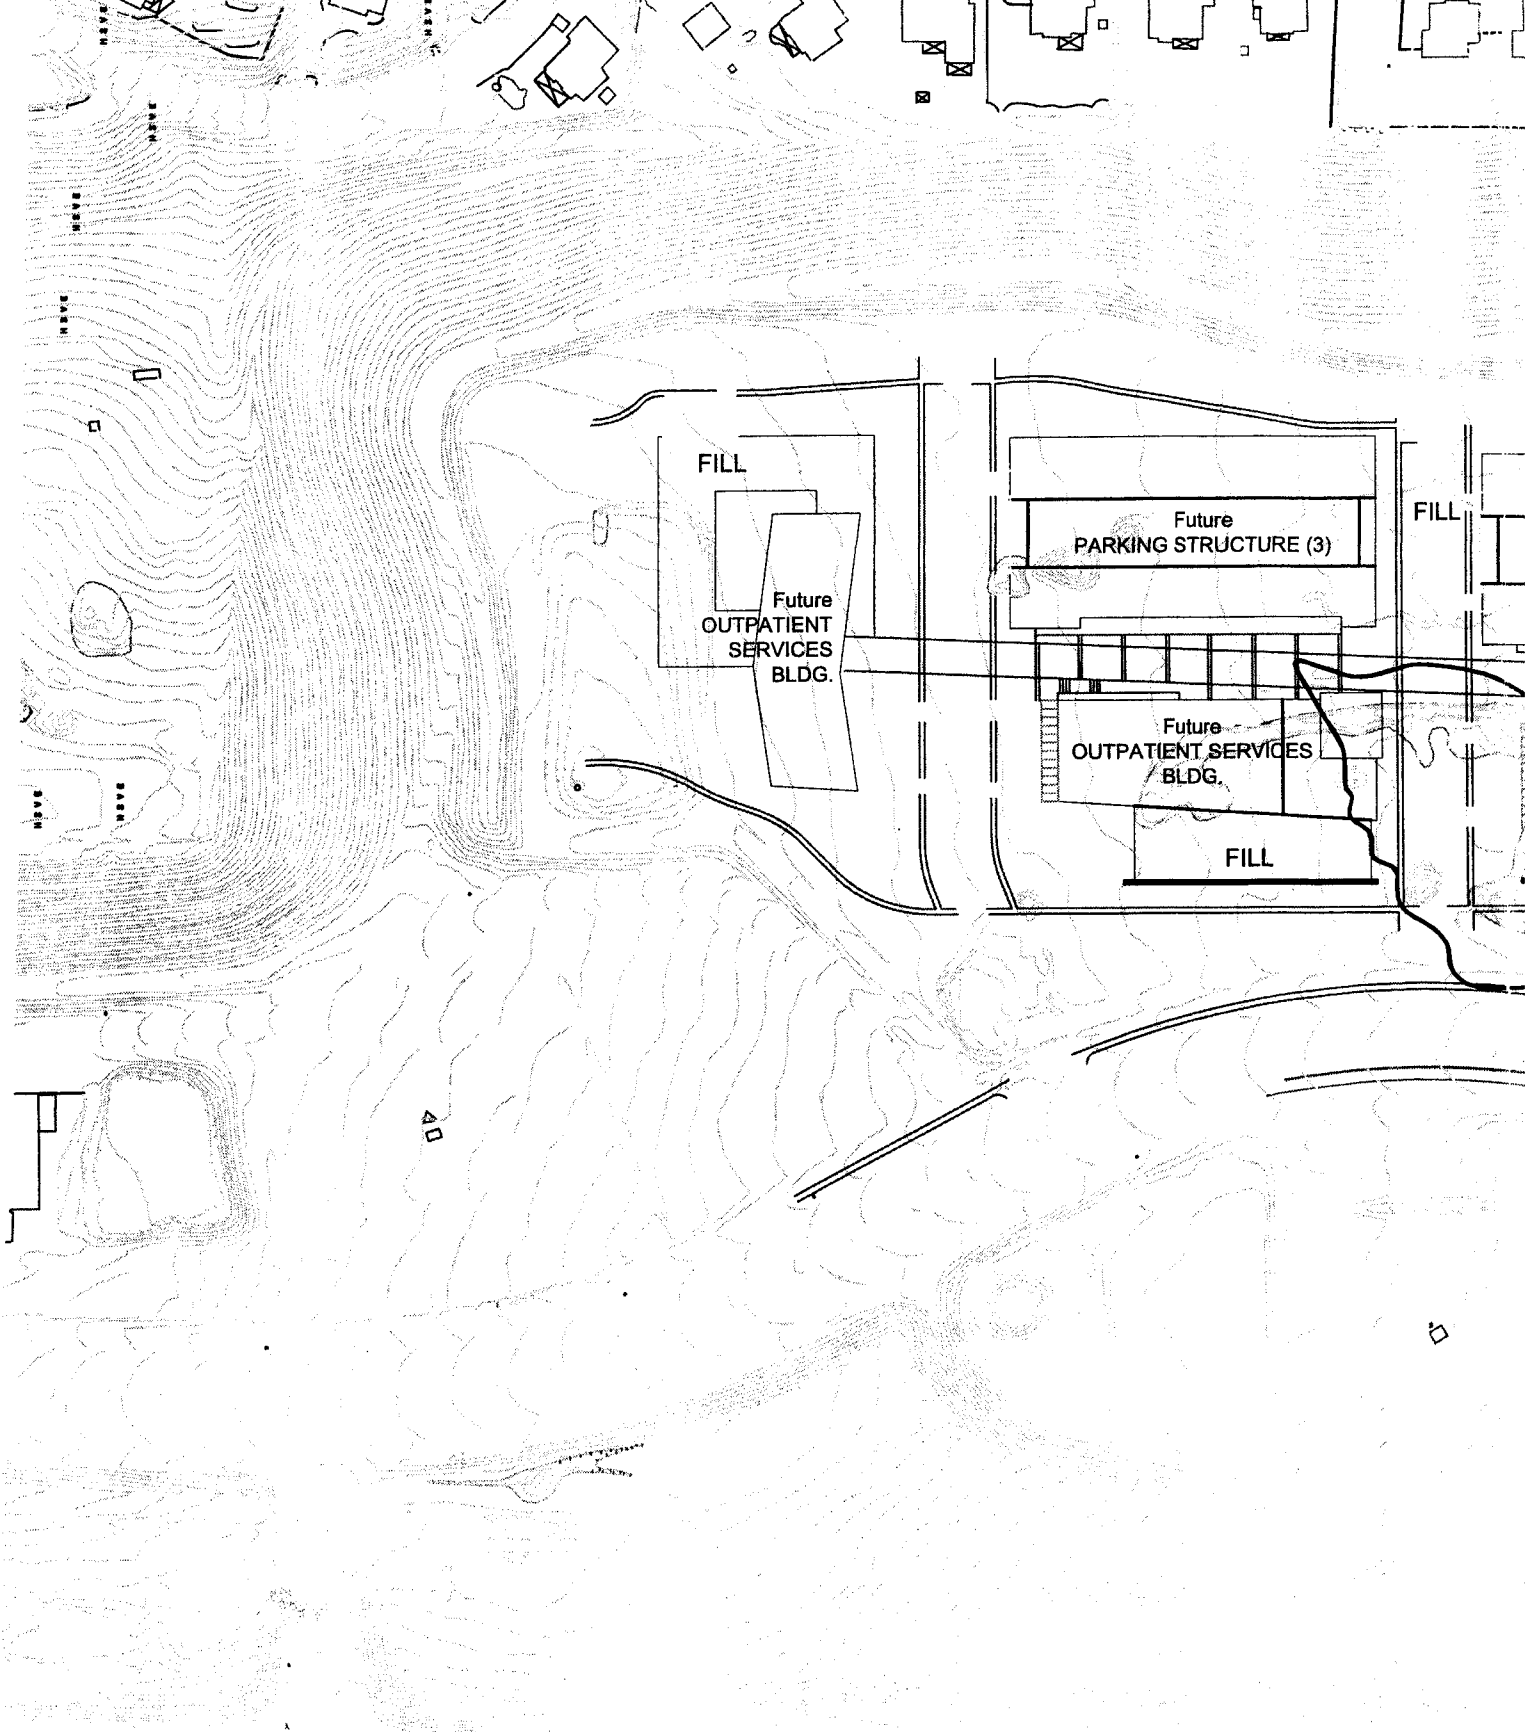
FIGURE 3

BORING LOCATIONS - ERTC

When the drilling contractor attempted to bore through the supposedly fine grain well-compacted soil fill materials on the site at borings B-2, B-3 and B-4, he ran into sands, gravels, cobbles and boulders. The drilling equipment hollow stem auger hung up in the boulder field as the cobbles and boulders moved against the side of the casing causing damage to the equipment. This contractor was forced to withdraw from the project without completing the program of drilling in early May 2005.

In summary, the five preliminary borings – 2 in rock and 3 in fill extending into rock – proved that the fill materials at the site were merely rock fills and not soil fills as originally anticipated based on design drawings and geotechnical recommendations by GEOCON.

Attached is GEOVision's report of September 13, 2005 describing the geophysical survey that was conducted in borings B-1A, B-1, B-2 and B-3. This data also indicated the distinct boundaries between the rock fills and the native bedrock foundation.
