FIGURE 2: RETROFIT SCHEME FOR McLEOD TOWER -- LOBBY

**Campus**      **Palomar Medical Center**

**Subject: Review of Engineering Geology and Seismology for  
Palomar Memorial Hospital - Escondido**  
555 East Valley Parkway, Escondido, San Diego County, CA 92025  
OSHDP file #1953-004-37

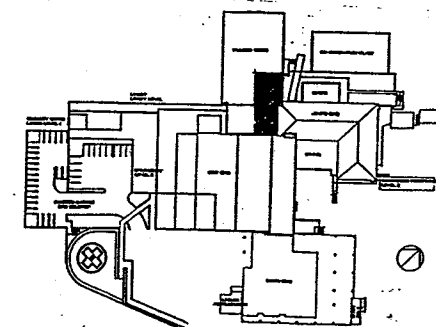
FIGURE 3

12" New Concrete  
Shear Wall (typical)

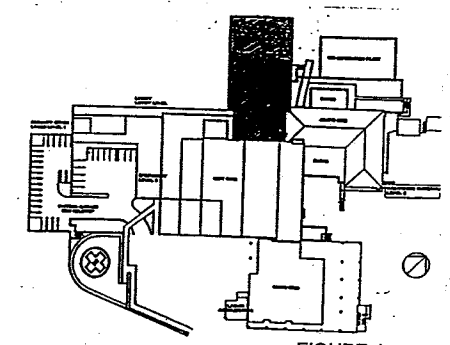
FIGURE 4

12" New Concrete  
 Shear Wall (typical)

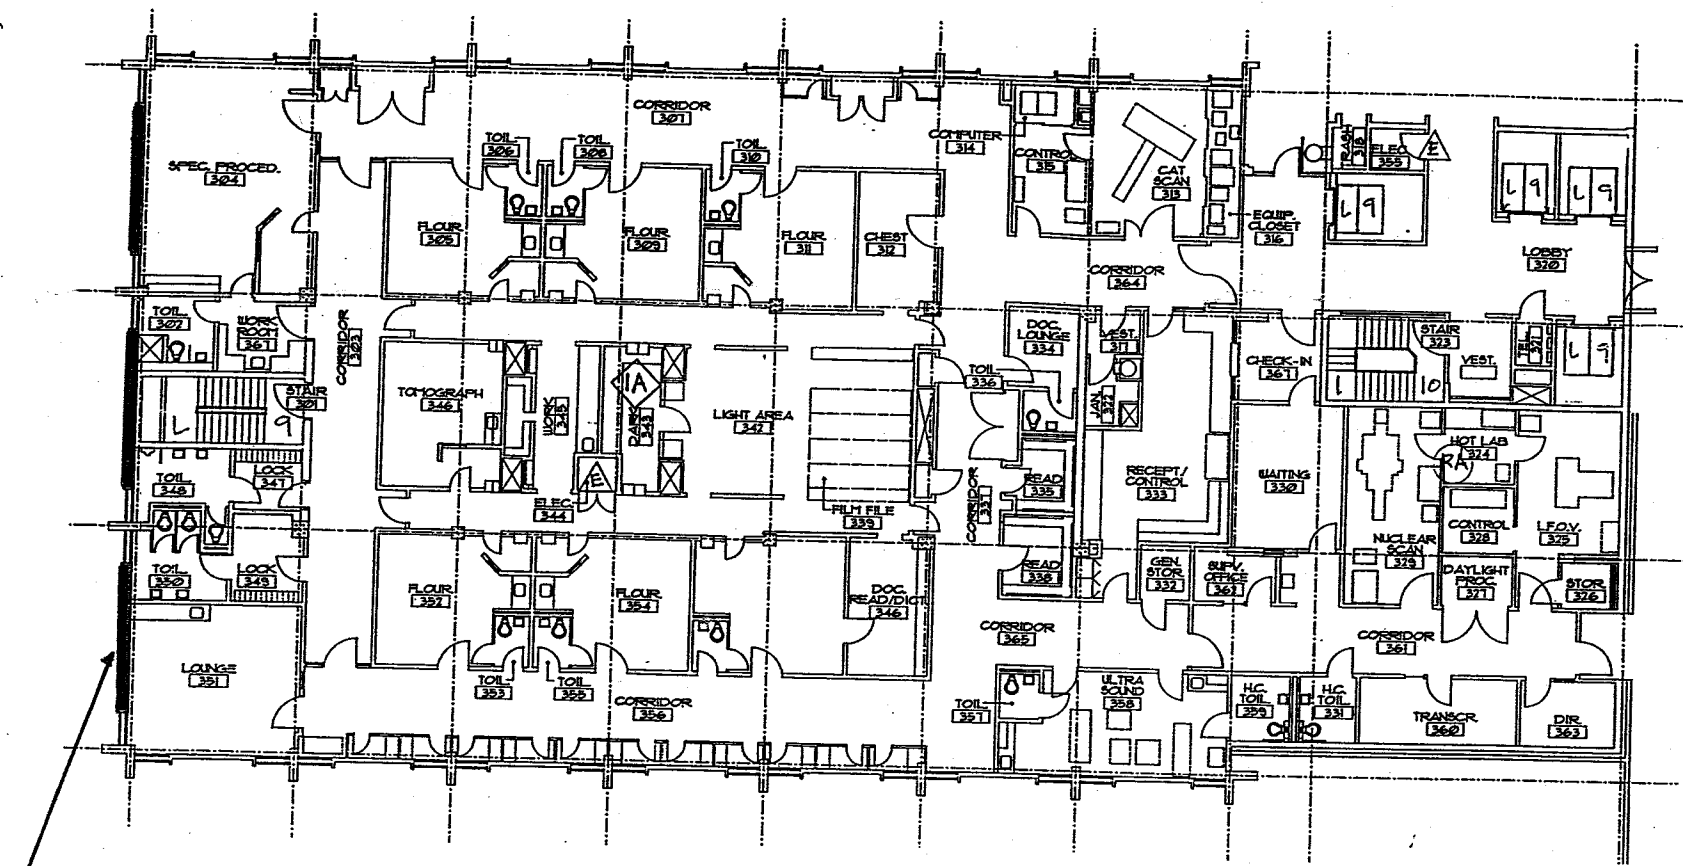
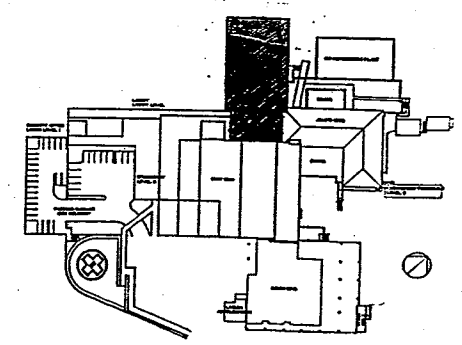
FIGURE 5

12" New Concrete  
 Shear Wall (typical)

RA ENTIRE FLOOR

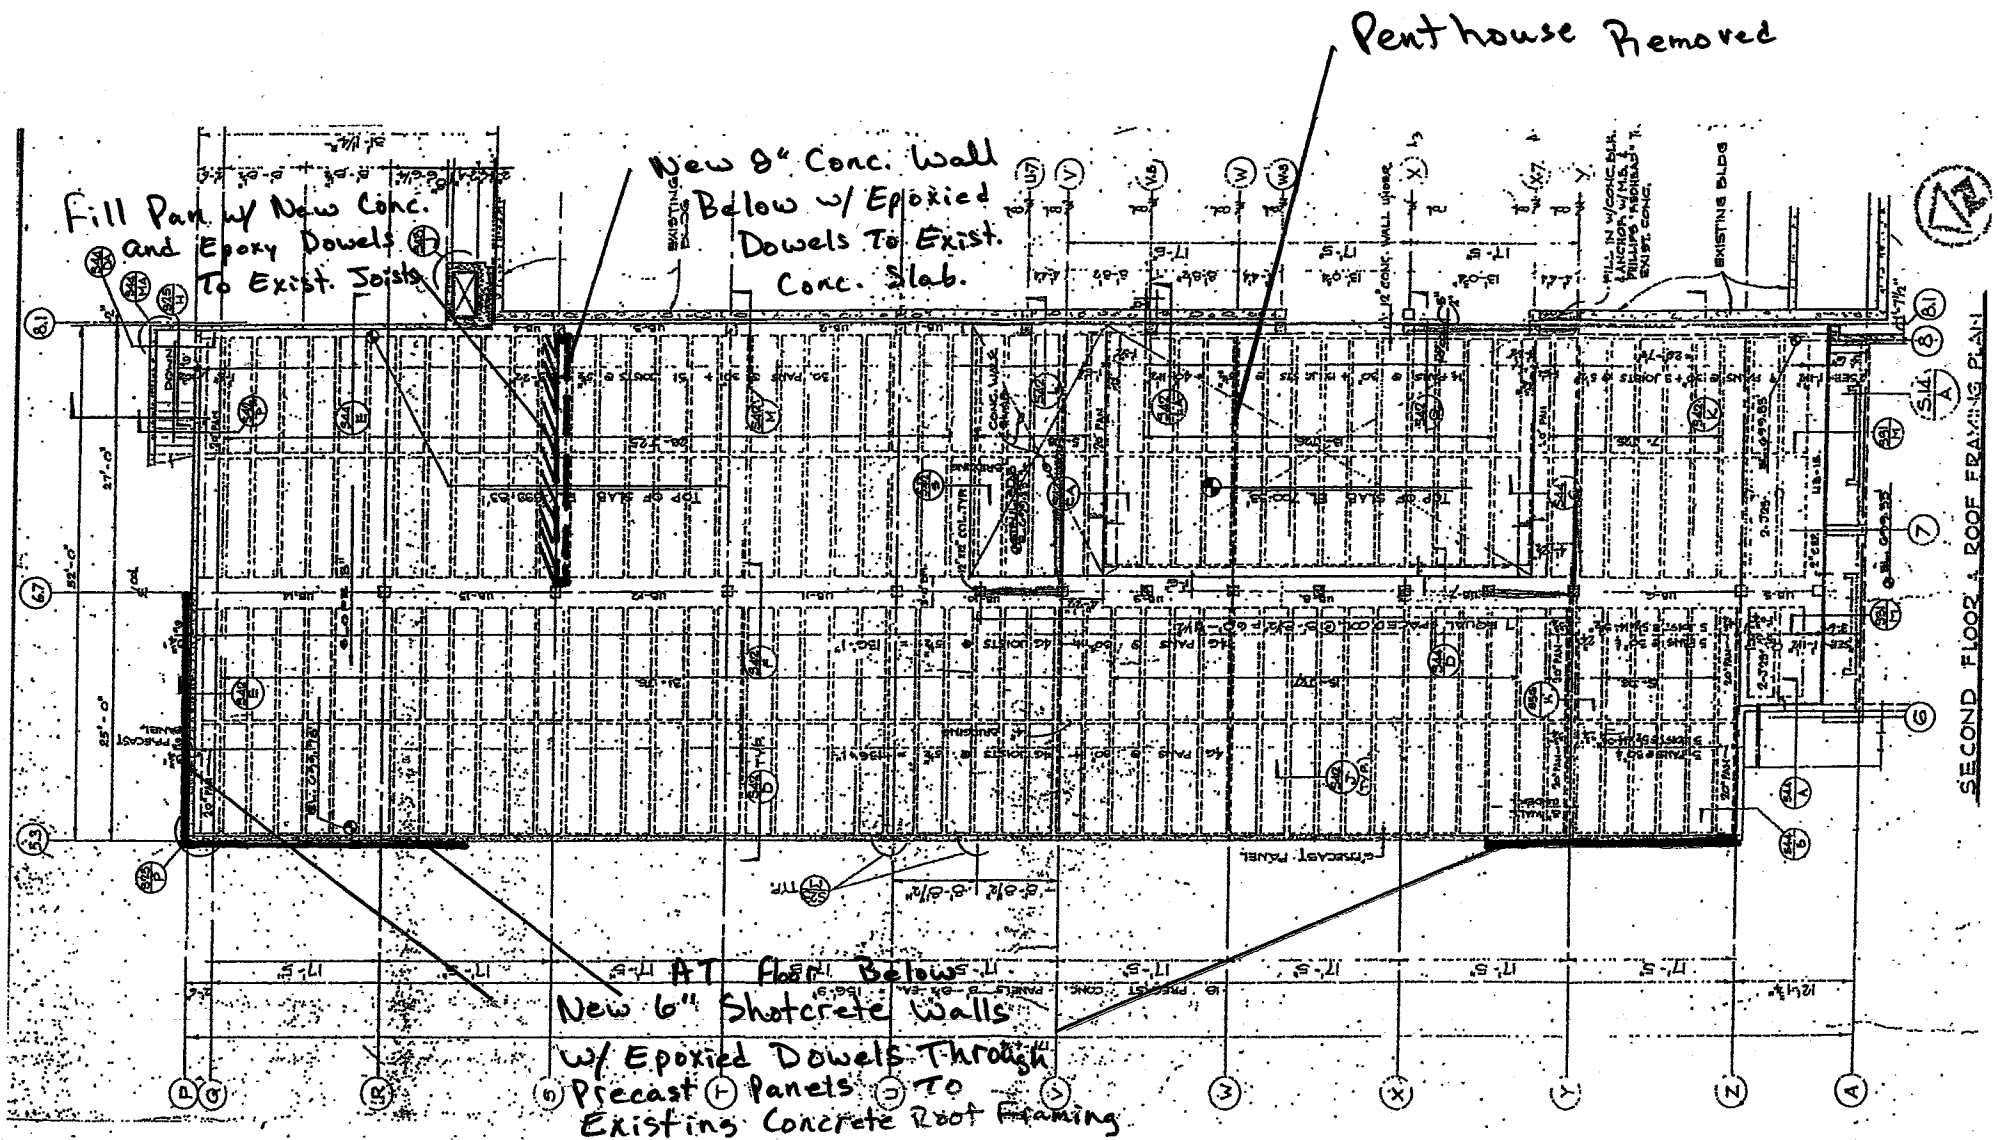
FIGURE 9

RUTHERFORD & CHEKENE a california corporation	CONSULTING ENGINEERS	Palomar Medical Center- Conceptual Retrofit Scheme #1 for McLeod Tower East Extension		Sheet 1 of 3
303 Second Street, Suite 800 North San Francisco, California 94107	(415)495-4222	Job No.: 98148S	By: BRR	Scale: NTS
		Date: SEPT 1999

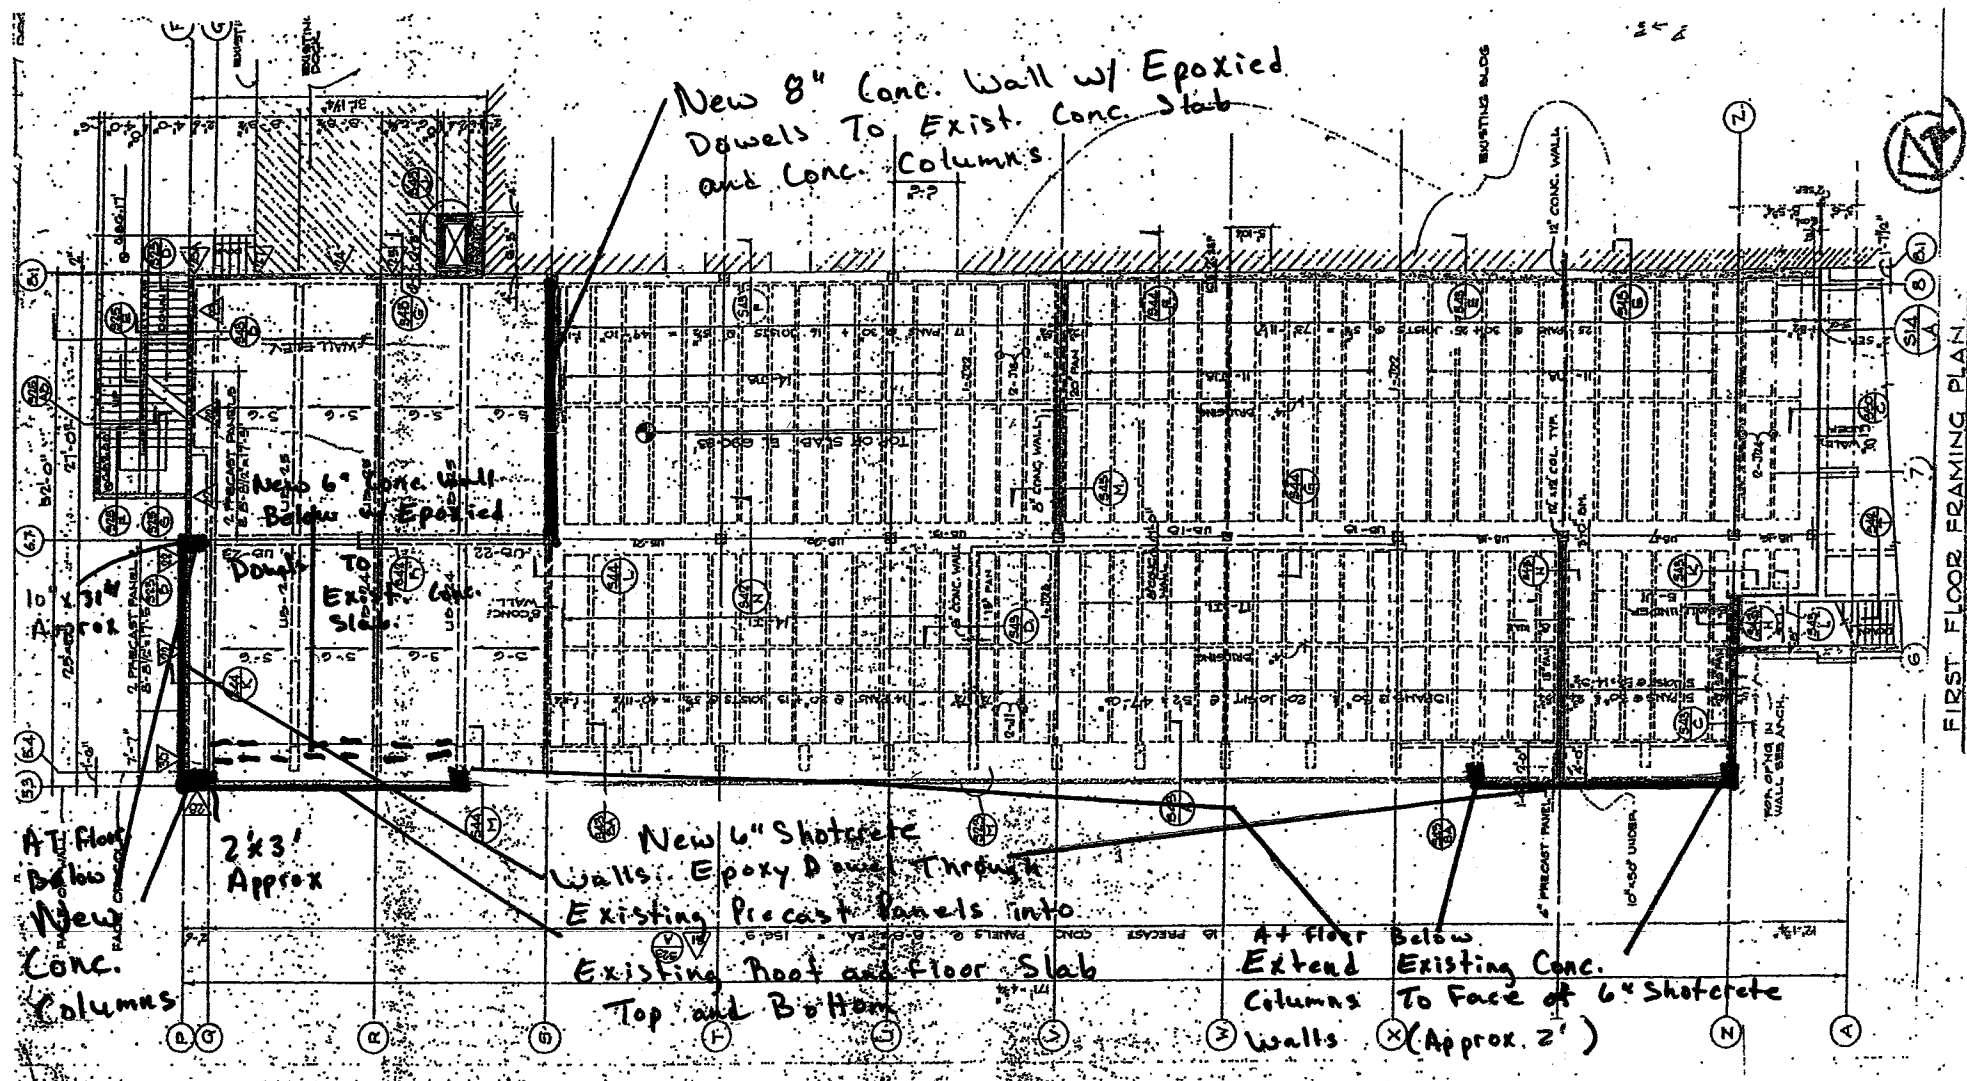
FIGURE 10

RUTHERFORD & CHEKENE a california corporation  303 Second Street, Suite 800 North San Francisco, California 94107	CONSULTING ENGINEERS  (415)495-4222	Palomar Medical Center- Conceptual Retrofit Scheme #1 for McLeod Tower East Extension			Sheet 2 of 3
		Job No.: 98148S	By: BRR	Scale: NTS	Date: SEPT 1999

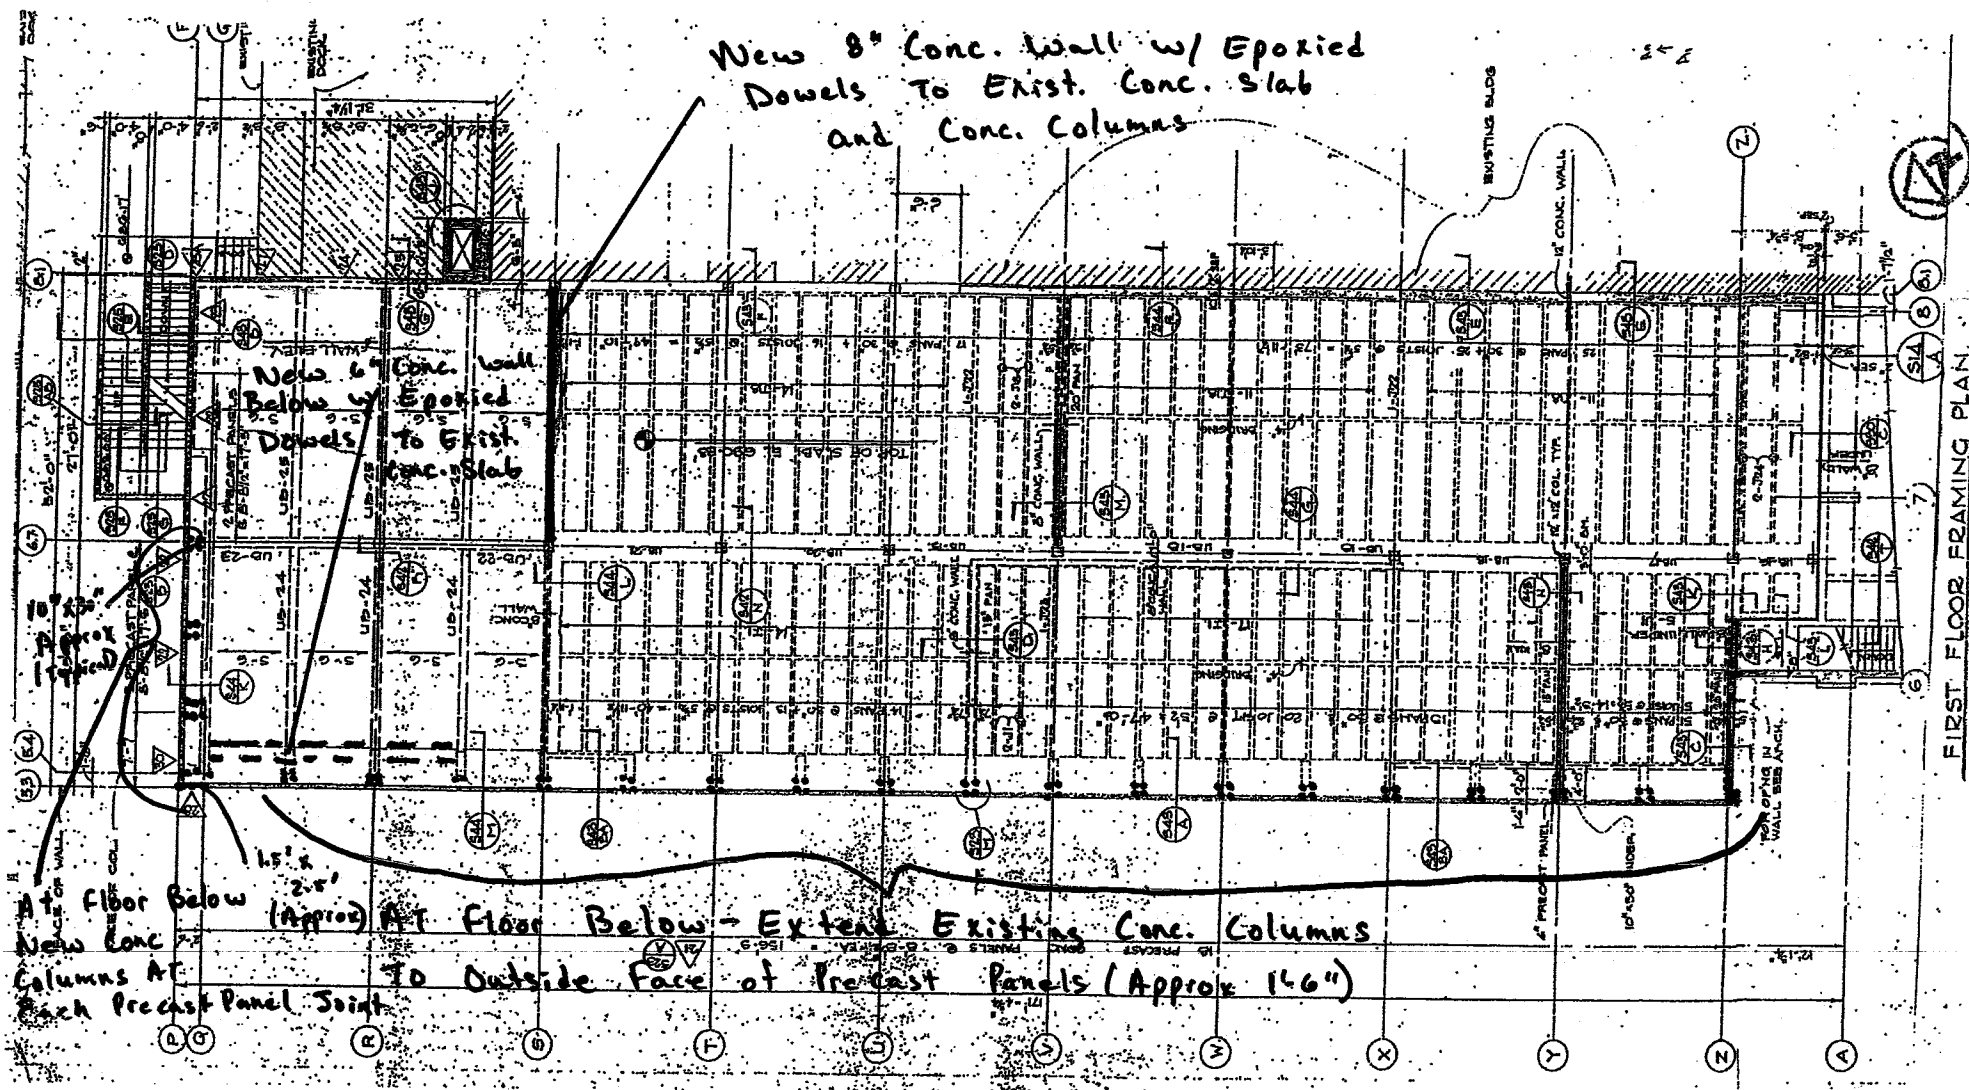
FIGURE 13

RUTHERFORD & CHEKENE a california corporation	CONSULTING ENGINEERS	Palomar Medical Center- Conceptual Retrofit Scheme #2 for McLeod Tower East Extension		Sheet 2 of 3
303 Second Street, Suite 800 North San Francisco, California 94107	(415)495-4222	Job No.: 98148S	By: BRR	Scale: NTS
		Date: SEPT 1999

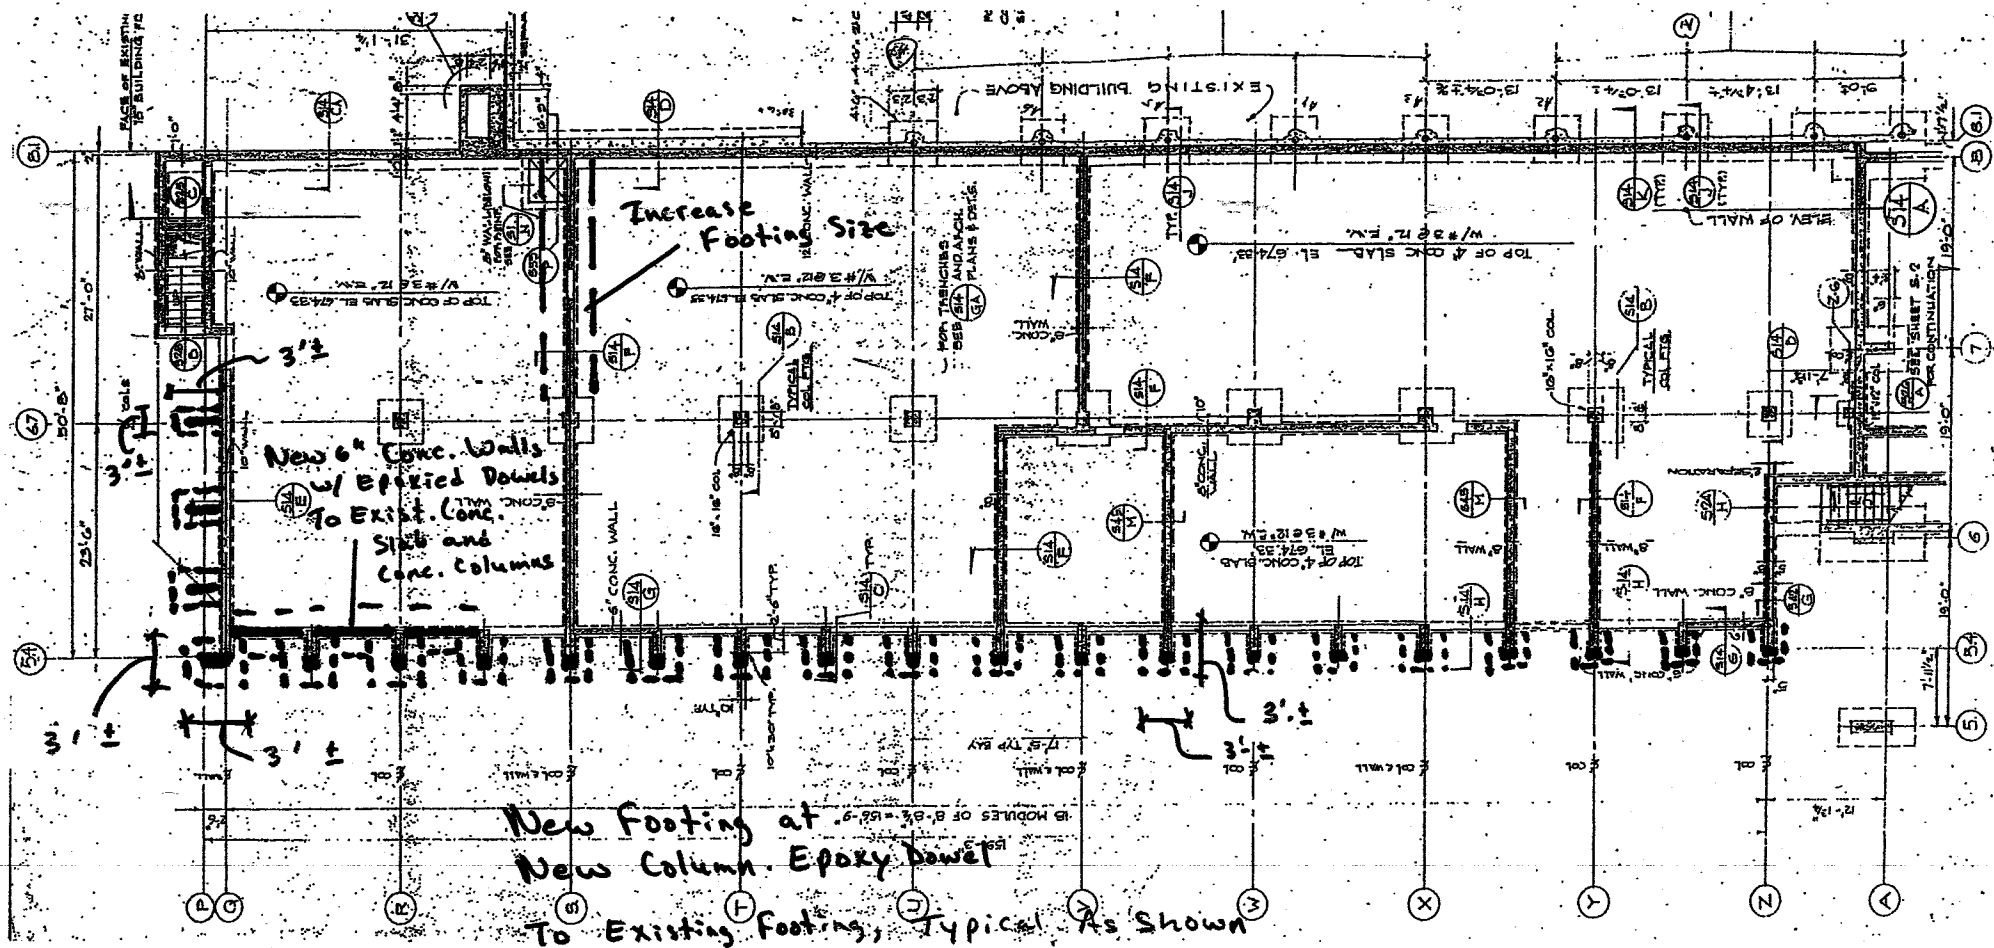
FIGURE 14

<b>RUTHERFORD &amp; CHEKENE</b> a california corporation	<b>CONSULTING ENGINEERS</b>	Palomar Medical Center- Conceptual Retrofit Scheme #2 for McLeod Tower East Extension		Sheet 3 of 3
303 Second Street, Suite 800 North San Francisco, California 94107		Job No.: 98148S	By: BRR	Scale: NTS
(415)495-4222				Date: SEPT 1999

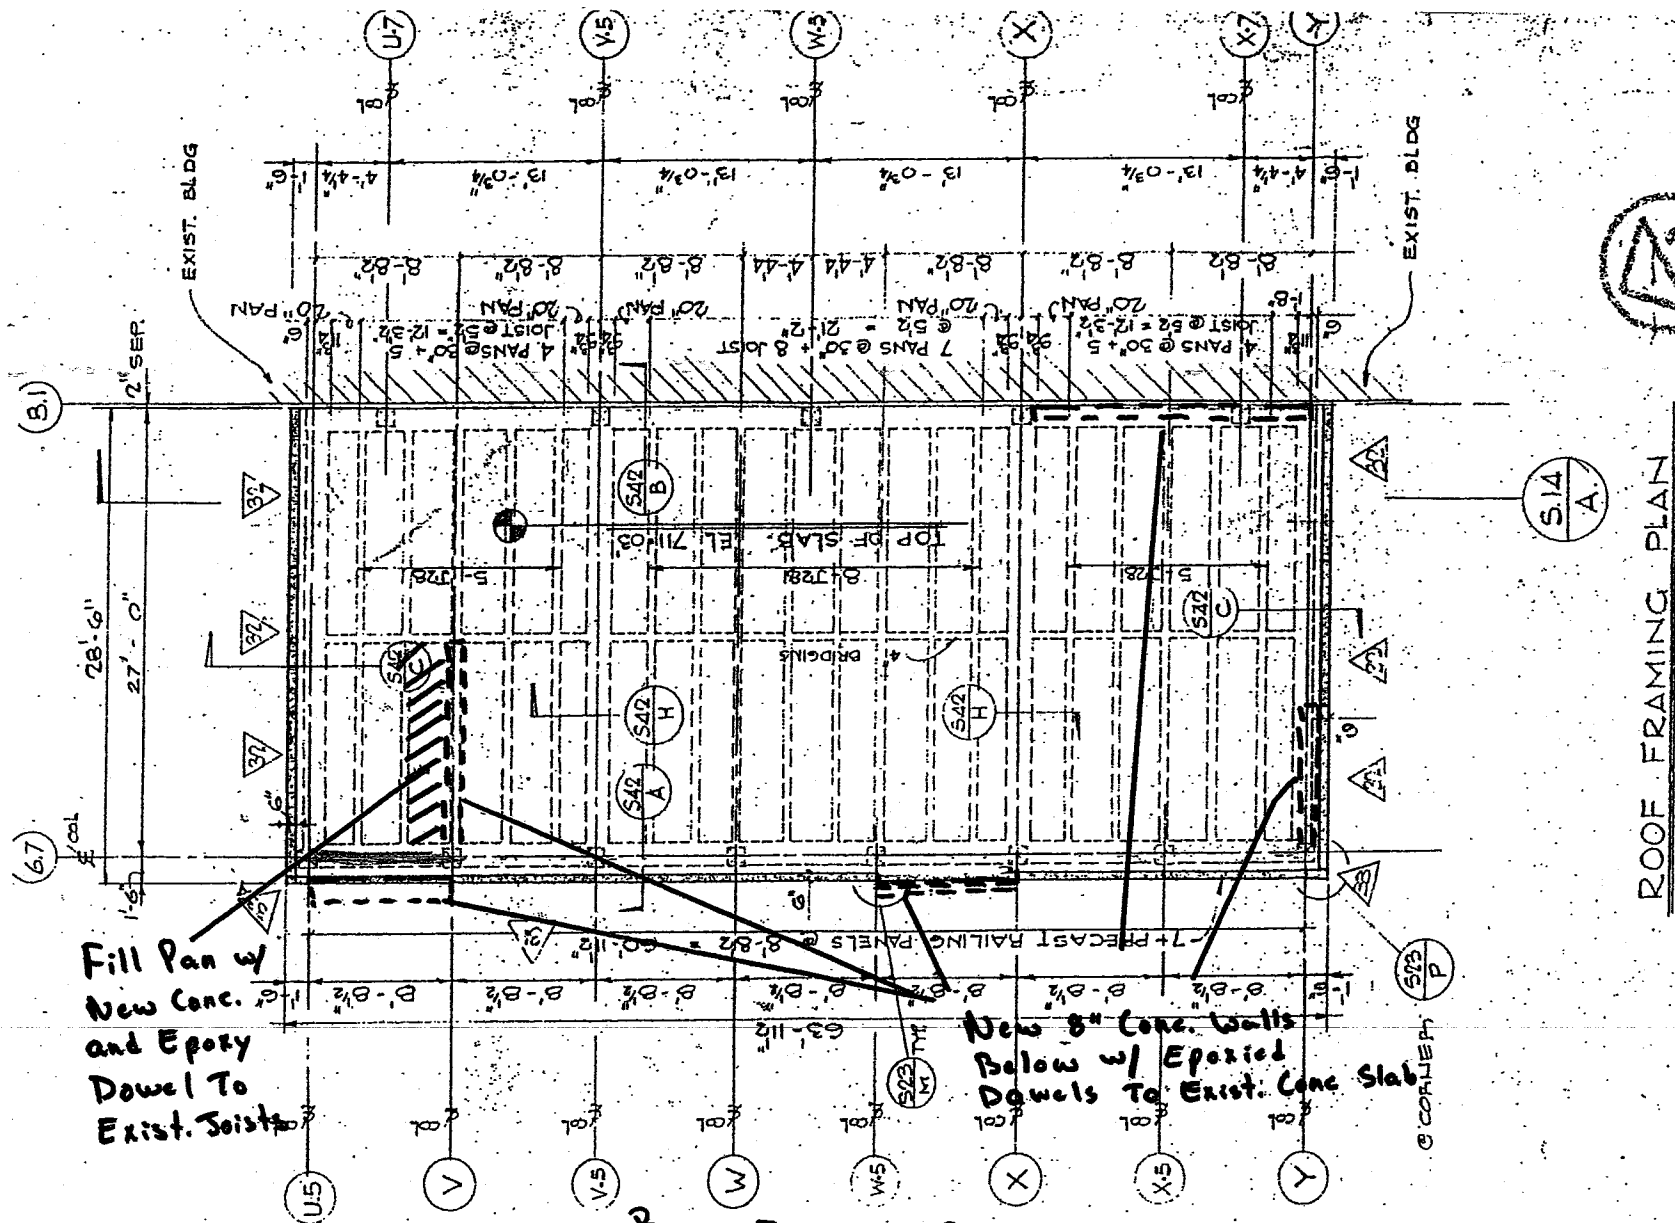
FIGURE 15

RUTHERFORD & CHEKENE a california corporation	CONSULTING ENGINEERS	Palomar Medical Center- Conceptual Retrofit Scheme #3 for McLeod Tower East Extension	Sheet 1 of 4
303 Second Street, Suite 800 North San Francisco, California 94107	(415)495-4222	Job No.: 98148S By: BRR	Scale: NTS
Date: SEPT 1999

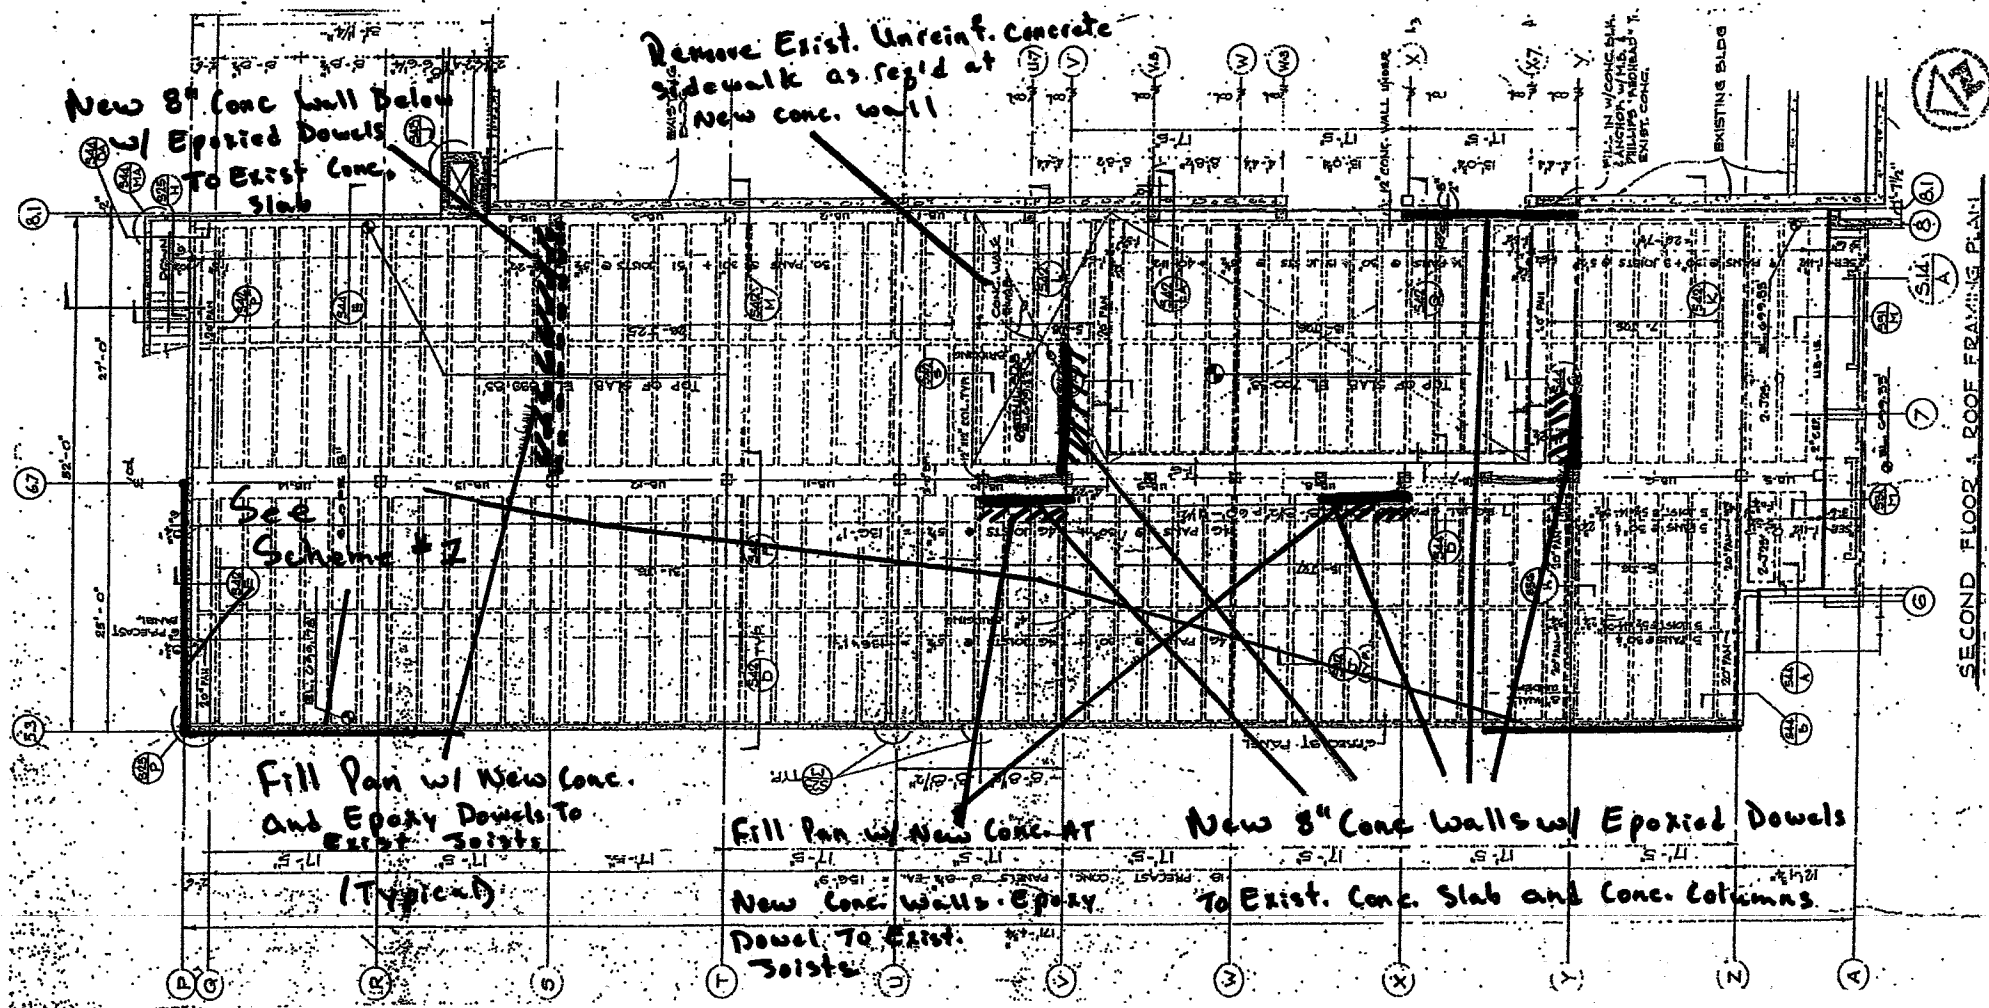
FIGURE 16

RUTHERFORD & CHEKENE a california corporation	CONSULTING ENGINEERS	Palomar Medical Center- Conceptual Retrofit Scheme #3 for McLeod Tower East Extension		Sheet 2 of 4
303 Second Street, Suite 800 North San Francisco, California 94107		Job No.: 98148S	By: BRR	Scale: NTS
(415)495-4222				Date: SEPT 1999

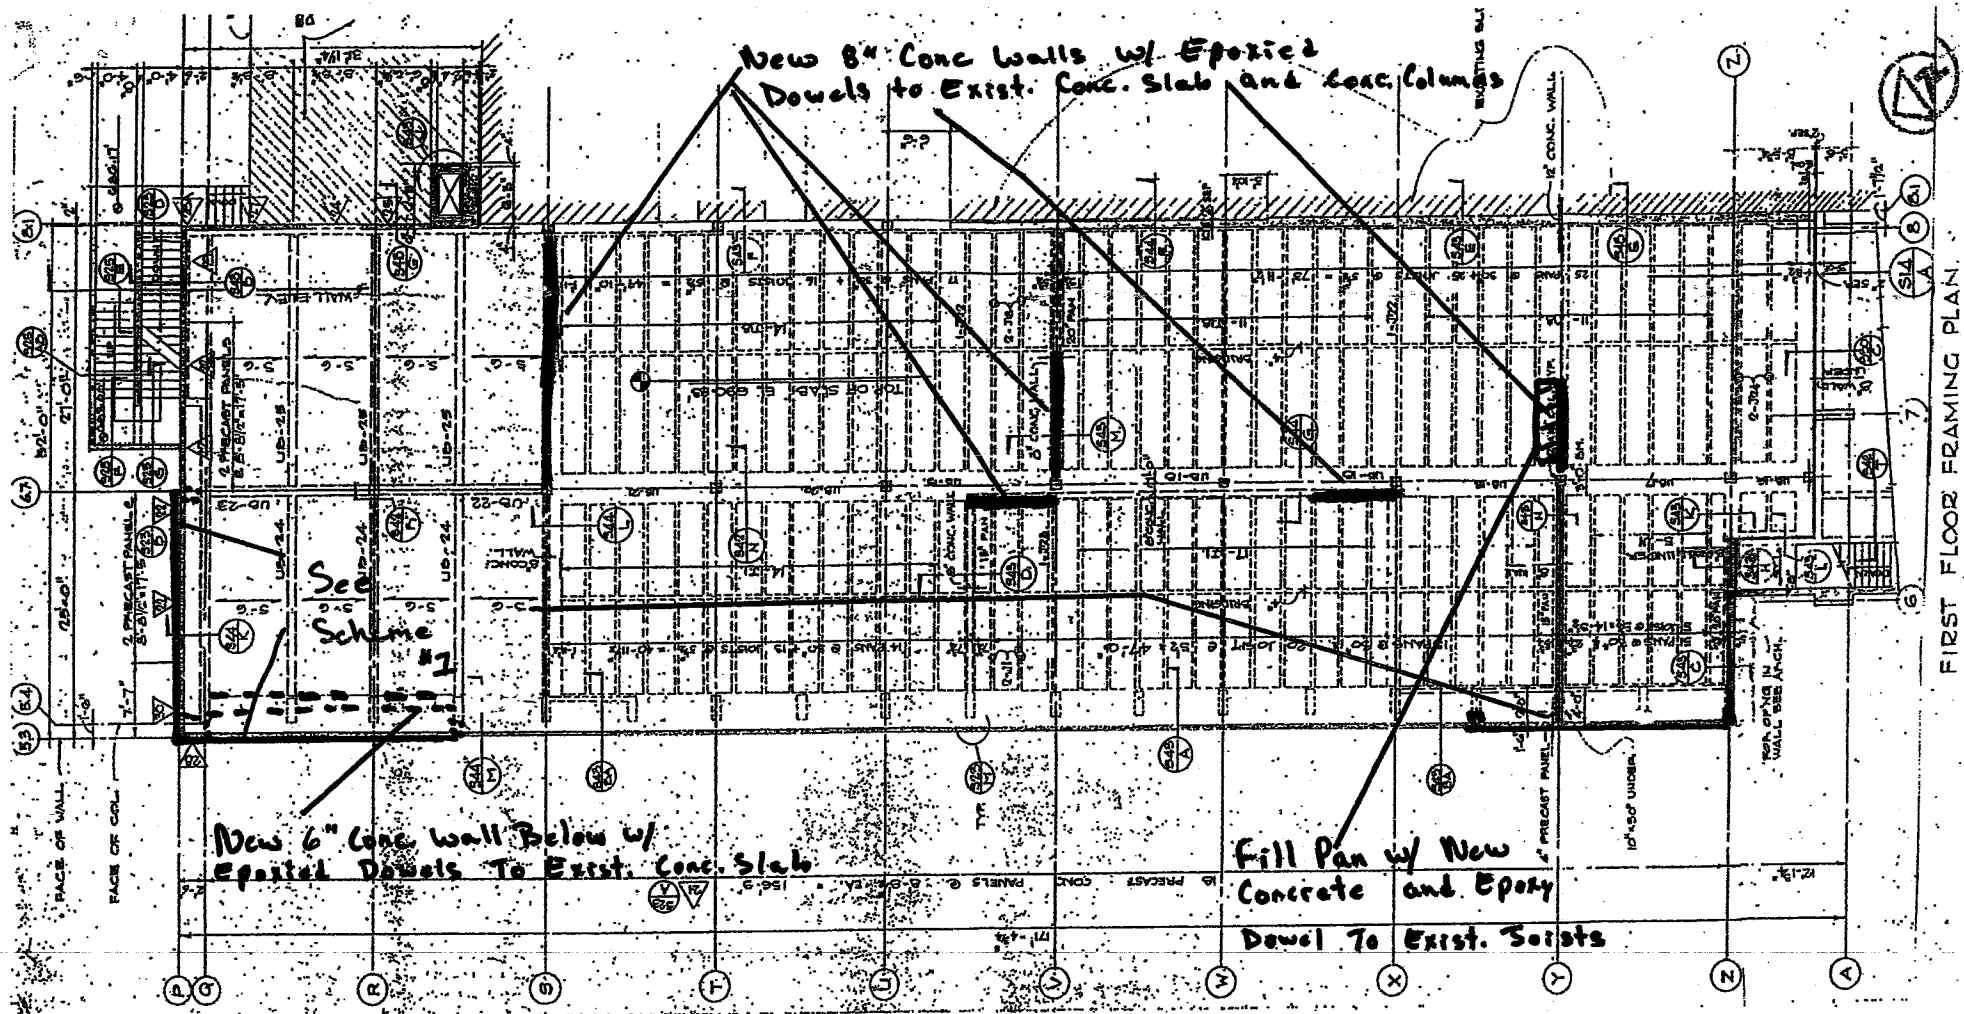
FIGURE 17

<b>RUTHERFORD &amp; CHEKENE CONSULTING</b> a california corporation <b>ENGINEERS</b> 303 Second Street, Suite 800 North San Francisco, California 94107 (415)495-4222	Palomar Medical Center- Conceptual Retrofit Scheme #3 for McLeod Tower East Extension			Sheet 3 of 4
	Job No.: 98148S	By: BRR	Scale: NTS	Date: SEPT 1999

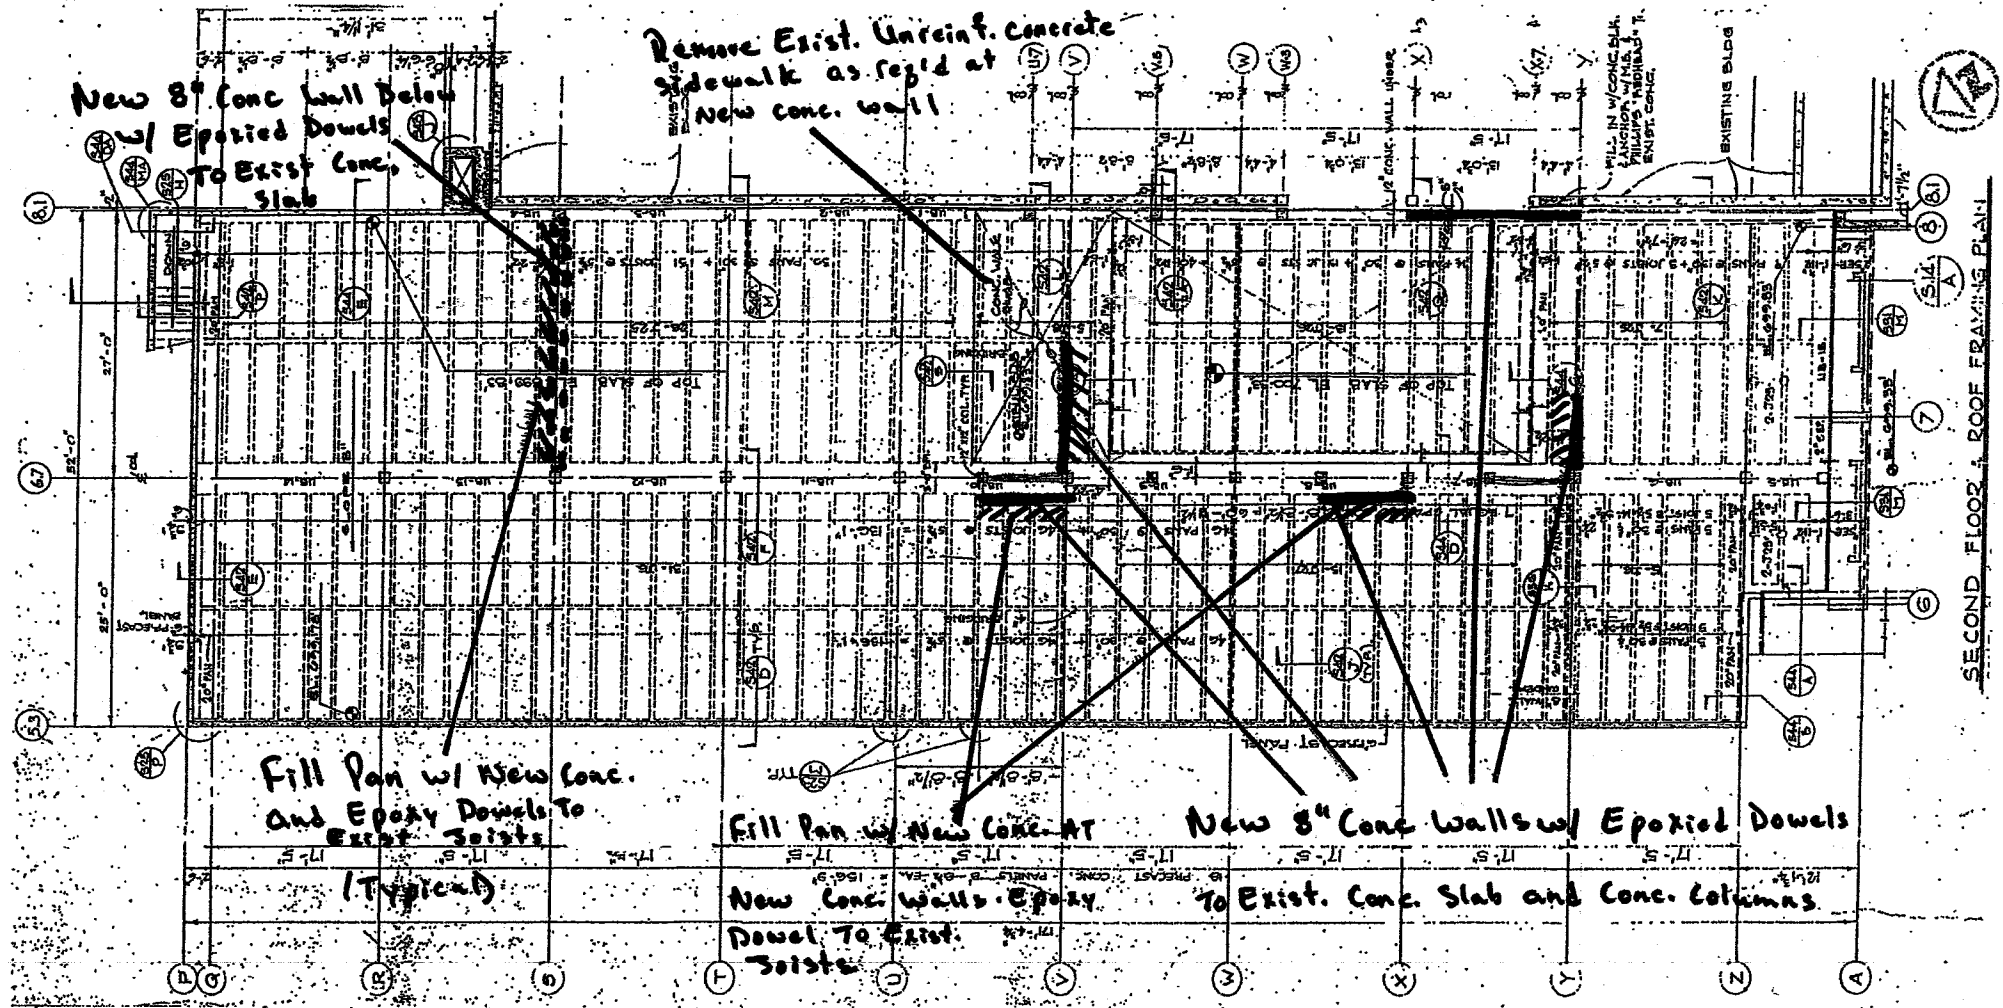
FIGURE 20

RUTHERFORD & CHEKENE	CONSULTING ENGINEERS	Palomar Medical Center- Conceptual Retrofit Scheme #4 for McLeod Tower East Extension	Sheet 2 of 4
303 Second Street, Suite 800 North San Francisco, California 94107	(415)495-4222	Job No.: 98148S By: BRR Scale: NTS	Date: SEPT 1999

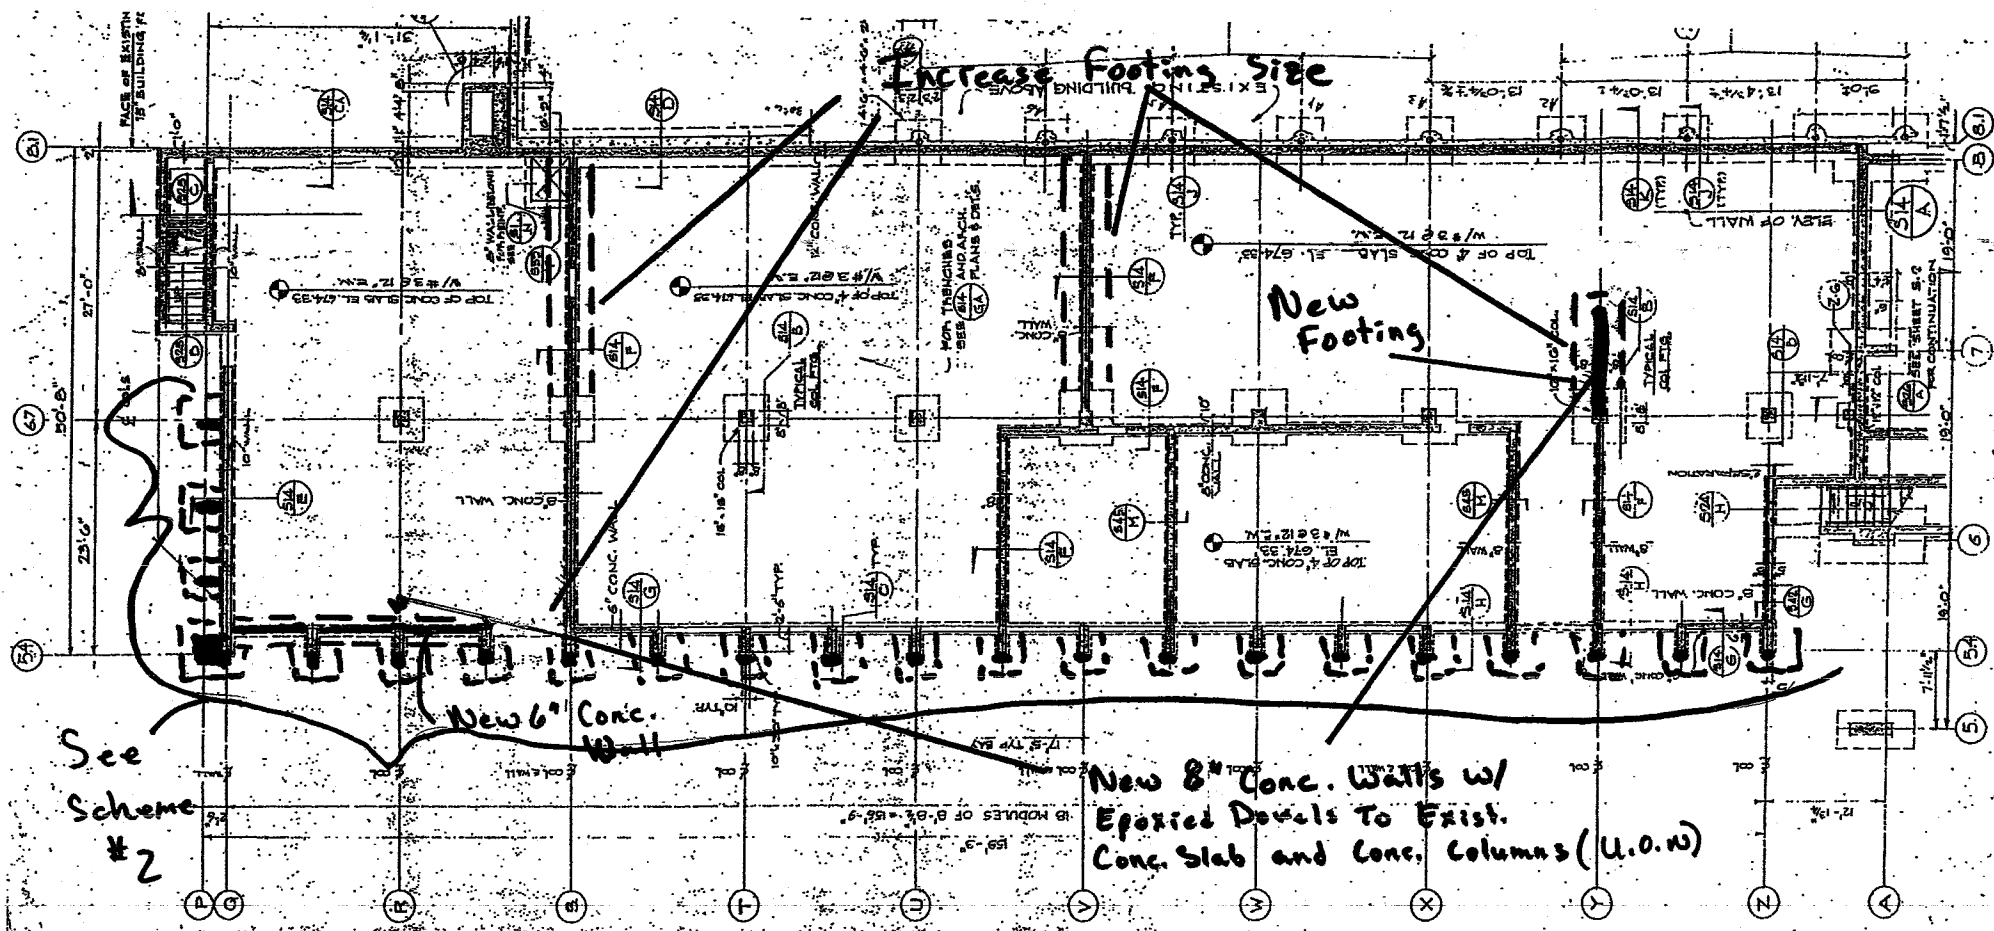
FIGURE 22

RUTHERFORD & CHEKENE a california corporation		CONSULTING ENGINEERS		Palomar Medical Center- Conceptual Retrofit Scheme #4 for McLeod Tower East Extension		Sheet 4 of 4	
303 Second Street, Suite 800 North San Francisco, California 94107		(415)495-4222		Job No.: 98148S	By: BRR	Scale: NTS	Date: SEPT 1999
