GEOTECHNICAL INVESTIGATION PALOMAR MEDICAL CENTER WEST ROADWAYS, PARKING, HARDSCAPES, UTILITES AND LANDSCAPES

**SW of Citracado Parkway and Vineyard Avenue
Escondido, California**

Subject: Report
Geotechnical Investigation
Roadways, Parking, Hardscapes, Utilities and Landscapes
Palomar Medical Center West
SW of Citracado Parkway and Vineyard Avenue, Escondido, California

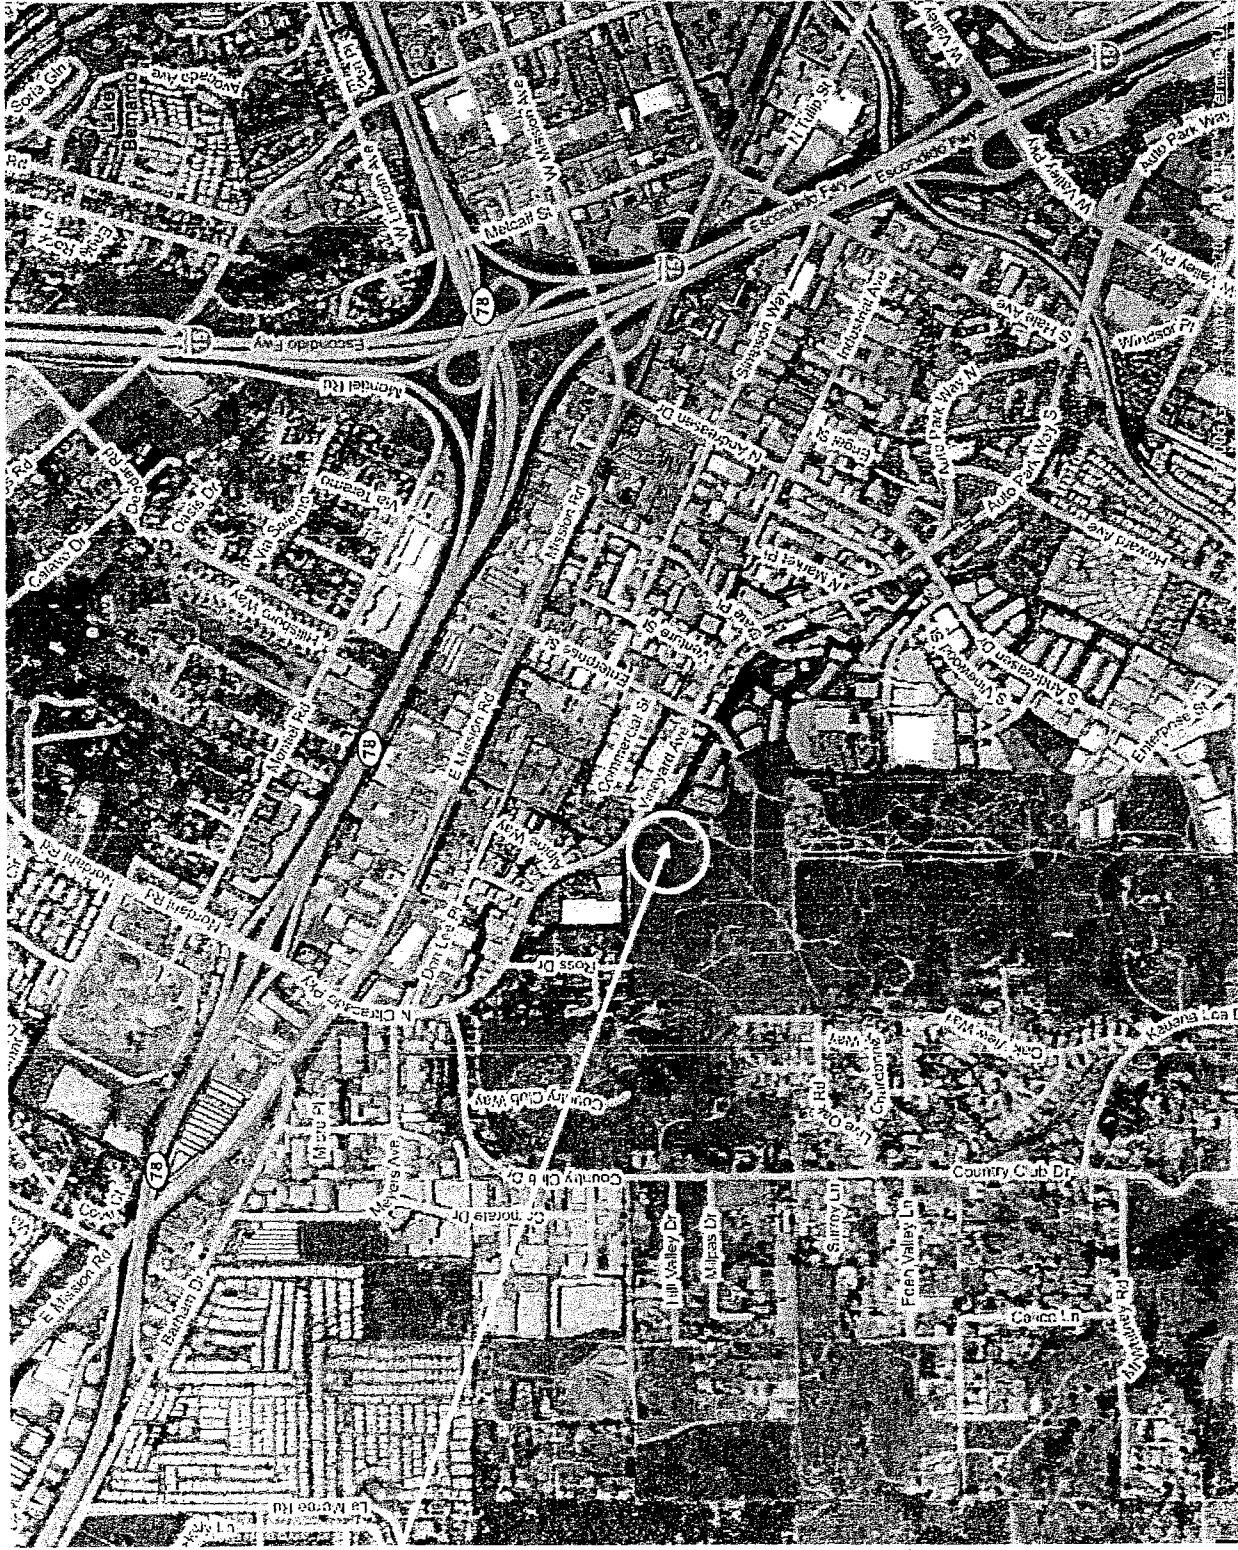
VICINITY MAP
 PALOMAR MEDICAL CENTER WEST
 SW OF VINEYARD AVE. & CITRACADO PKWY., ESCONDIDO, CALIFORNIA
 FOR: PALOMAR POMERADO HEALTH

This report presents the results of a series of geotechnical investigation performed by URS Corporation (URS) at the proposed Palomar Medical Center West to be located to the southwest of Citracado Parkway and Vineyard Avenue in the City of Escondido, California, approximately as shown on Figure 1. The site is located at approximately 33.1229 N and 117.1186 W° (NAD83), and is also known as the Escondido Research and Technology Center (ERTC) site. The proposed new medical center is shown on the Site Plan, Figure 2A. This geotechnical investigation was prepared specifically to address geotechnical conditions at the locations of roads, parking lots, site drainage, subterranean utilities, and landscaped areas. The OSHPD-regulated acute care buildings and the central plant for this project were addressed in a separate URS report dated April 21, 2006 with several addendums. The site was previously investigated by GEOCON in 2003 and was mass-graded under the purview of Geotechnical Exploration Incorporated (GEI) in 2005. The estimated thickness of cut and fill across the entire site as a result of the previous grading is shown on Figure 2B.

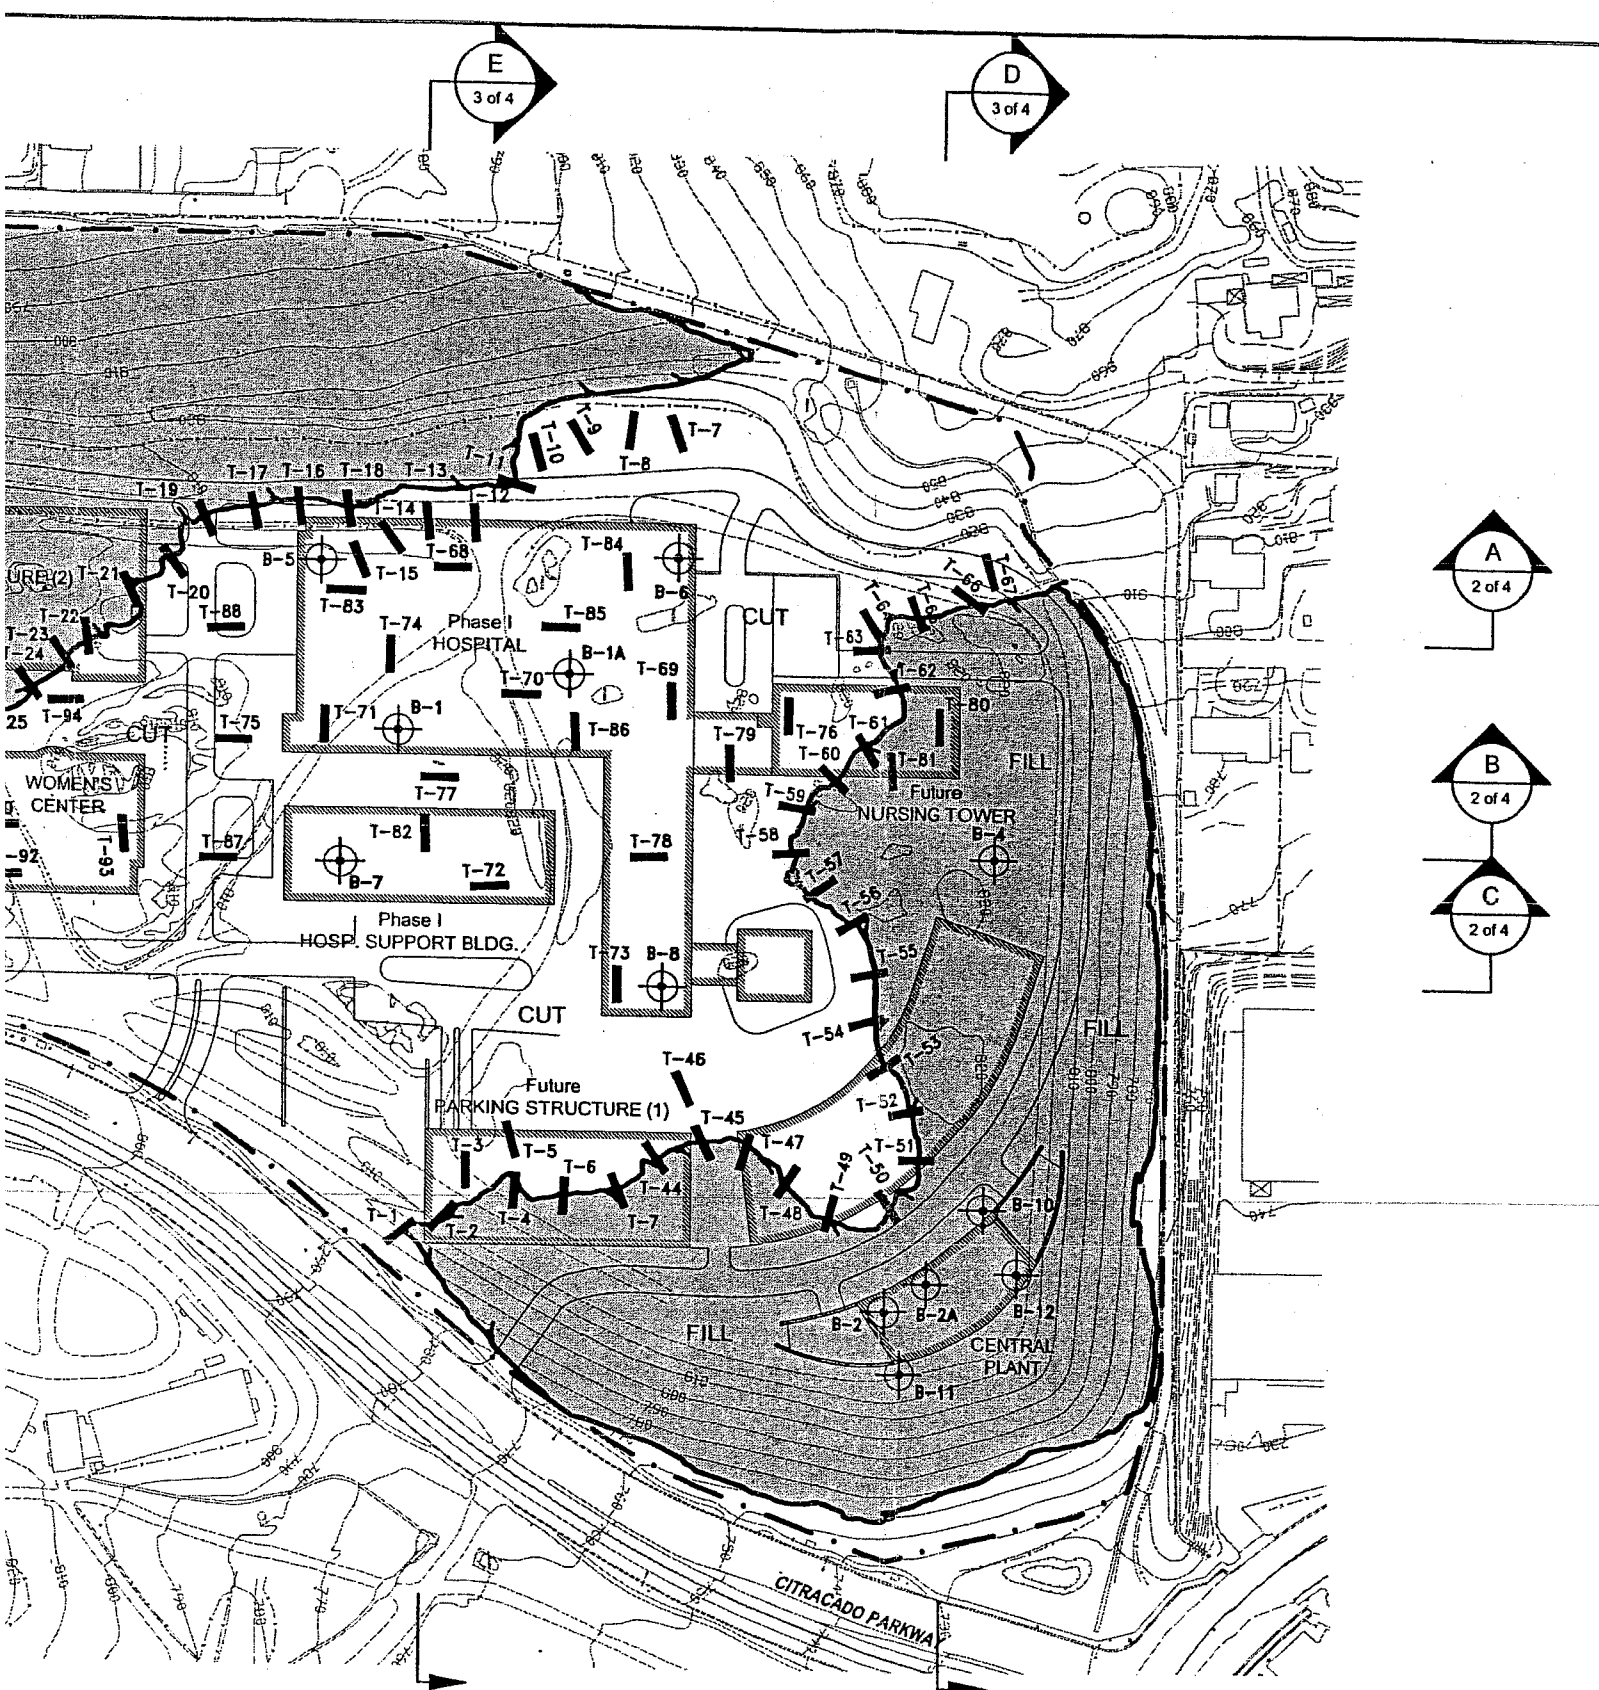
DATE	APP'D	SCALE:	PALOMAR MEDICAL CENTER WEST - ESCONDIDO, CA SITE PLAN	DRAWING NUMBER Figure 2
		DRAWN: D. Luong		
		CHECKED:		
		DESIGNED:		
		PROJ. MGR.		
		BILL GATES

A geotechnical field investigation at the medical center site, i.e., the northern portion of the ERTC site consisted of drilling 7 borings in the area for the hospital buildings and 5 borings in the area for the central plant by URS between May 2005 and January 2006. The field investigation locations are shown on the Site Plan, Figure 2A.

In addition to the borings, URS also excavated a total of 94 shallow test pits in the rock cut areas and along the cut-to-fill lines to verify the transition zone between cut and fill. The locations of these test pits are also shown on Figure 2A. A summary of the test pits is included in Appendix A, as Table A-1.

The subsurface geologic materials at the site consist of artificial fill (Af) underlain by granitic rocks (Kg), as shown on the Geologic Map, Figure 3. The subsurface distributions of the fill and bedrock with respect to the proposed development are shown on the North-south and East-west Cross-sections, Figures 4A and 4B. The locations of the cross-sections are shown on the Site Plan, Figure 2A.

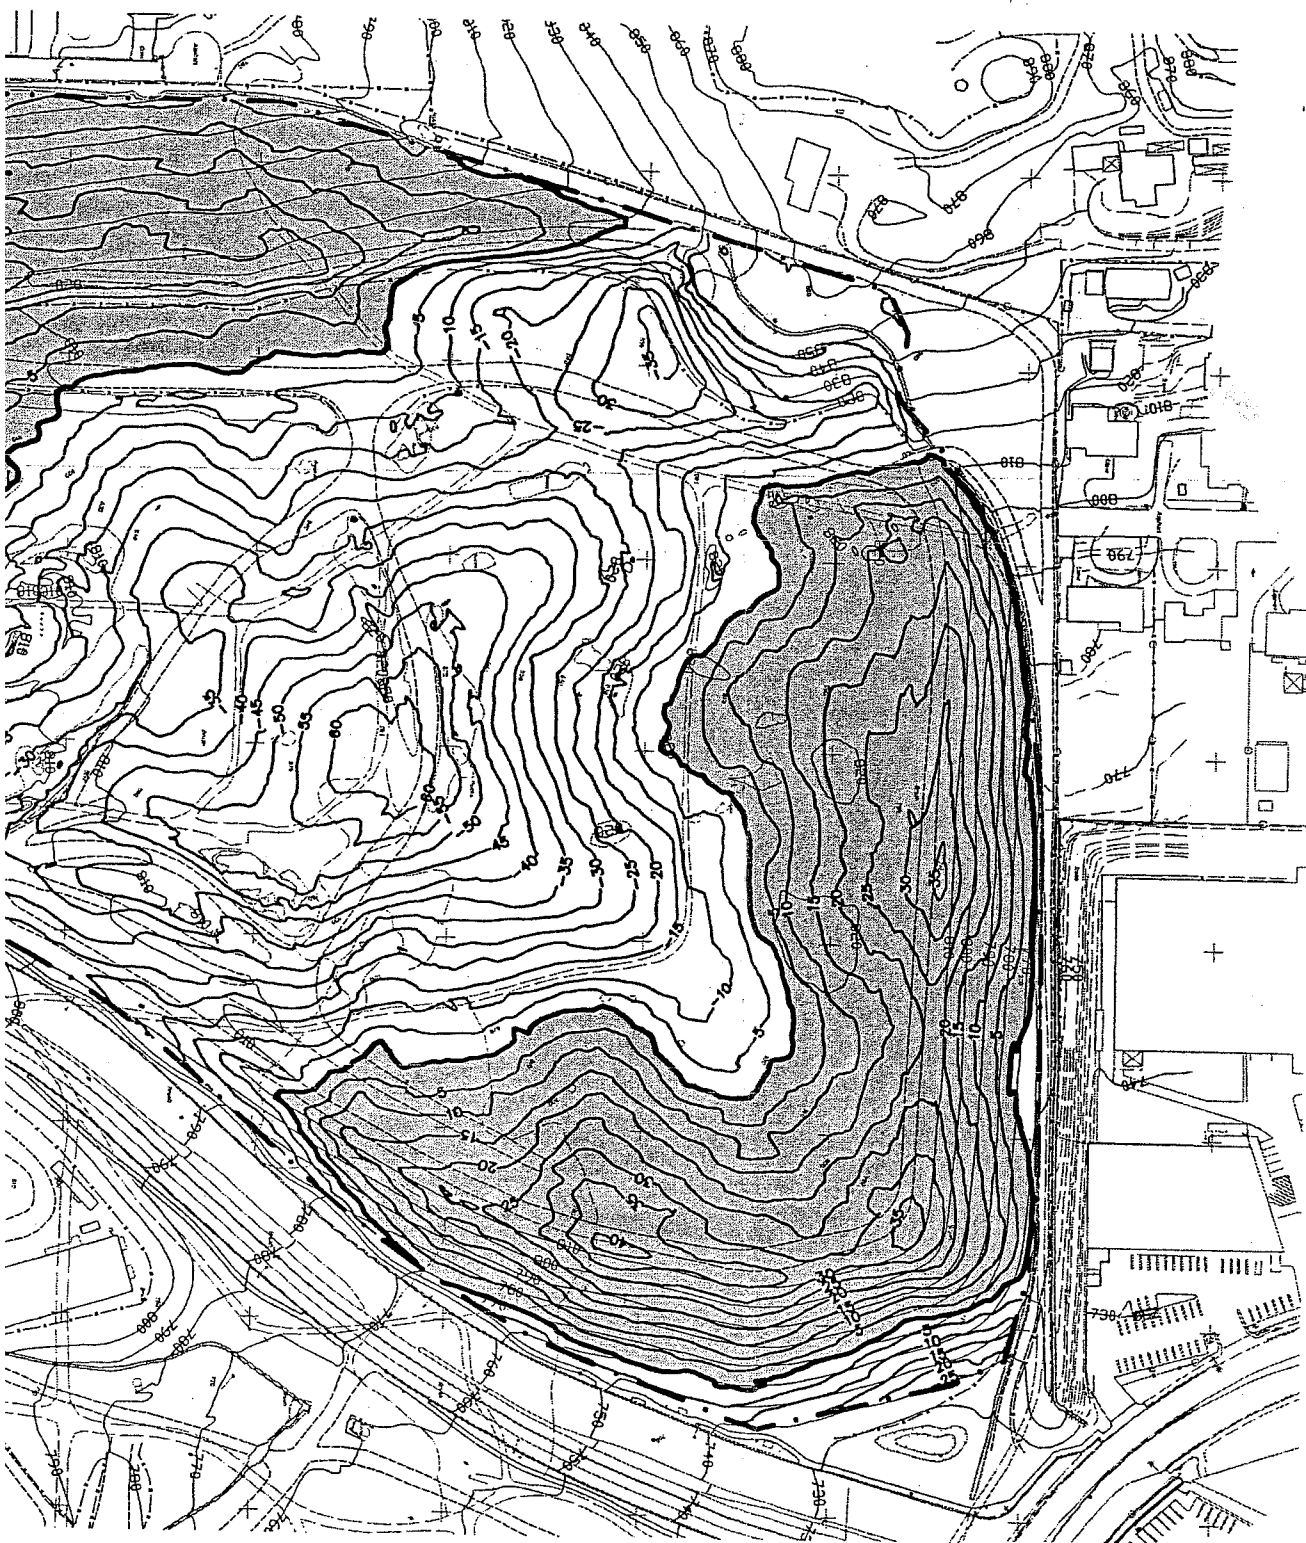
Figure 2B

SECTION A-A
 ELEVATION OF EXISTING SITE SURFACE
 10 FEET TURNS AFTER GRADING AND
 FINAL SITE CONTOURS PRIOR TO
 GRADING.

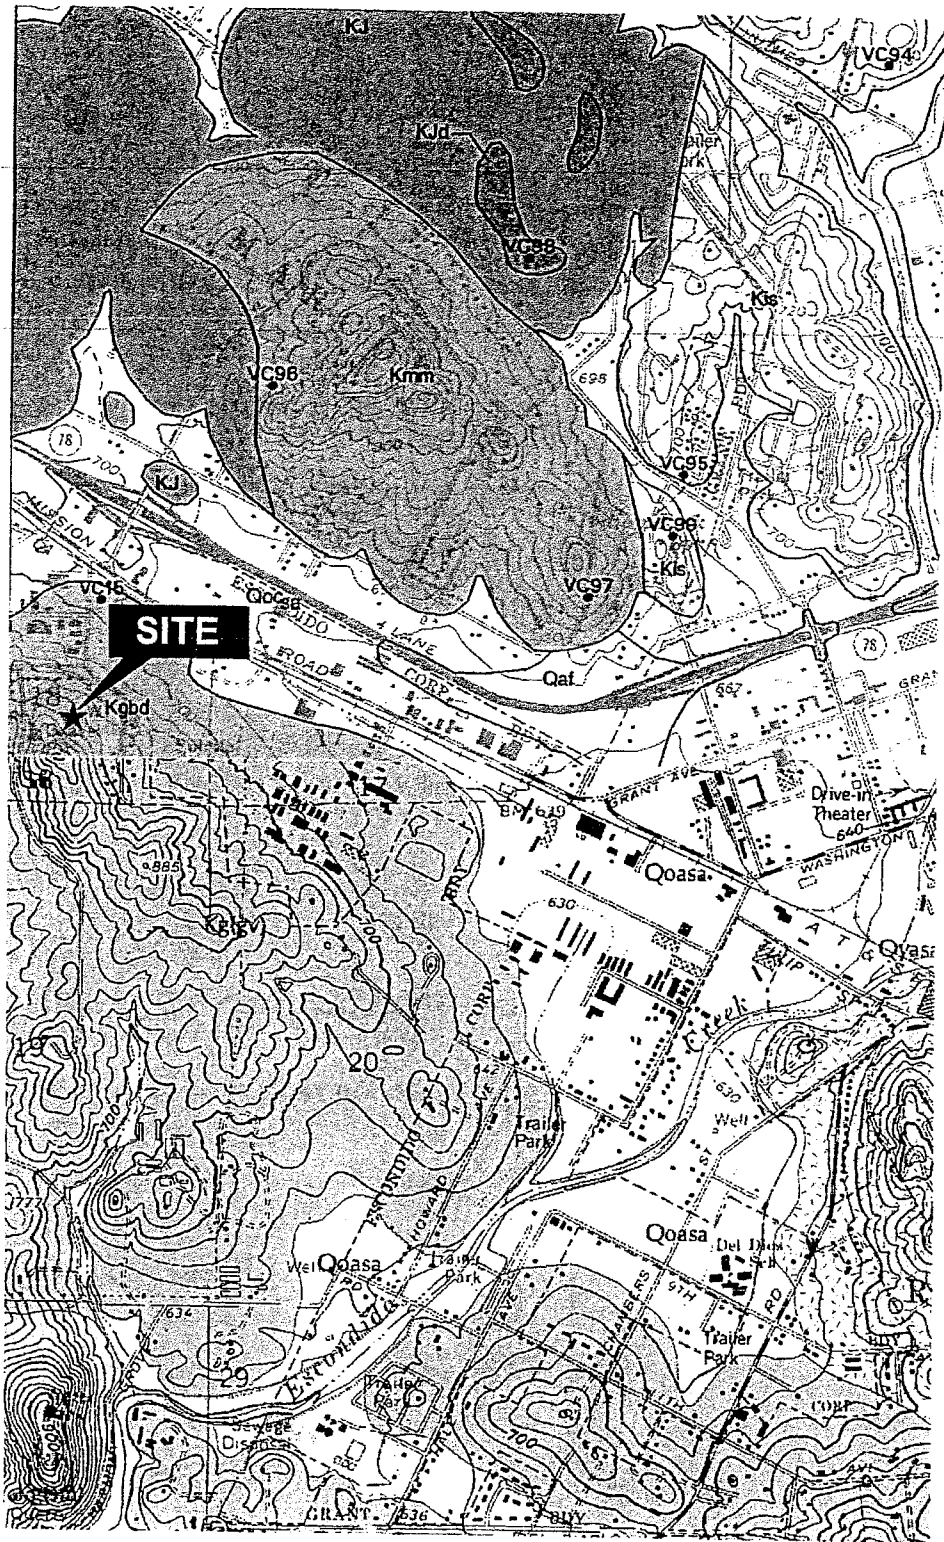
Source: USGS Geologic Map of the Escondido and Valley Center,
 7.5 Quadrangle San Diego County, CA.
 Department of Conservation Division of Mines and Geology.

The site is located entirely within a series of hills composed of granitic rocks of the Cretaceous age southern California batholith. The Escondido Valley is located east of the site and is underlain by Quaternary age alluvium. Figure 3 shows the general geologic setting for the site and surrounding area.

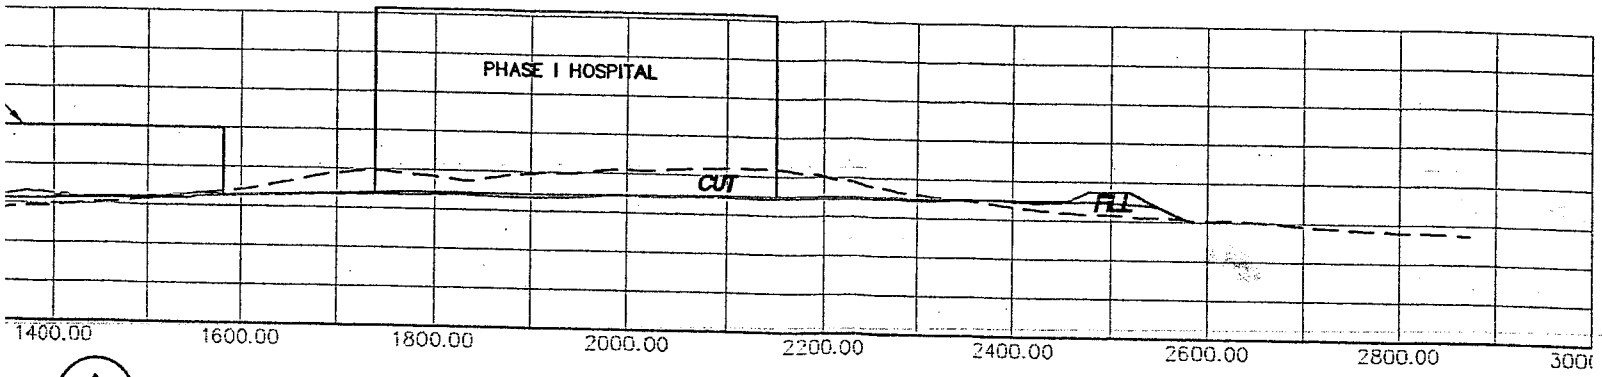
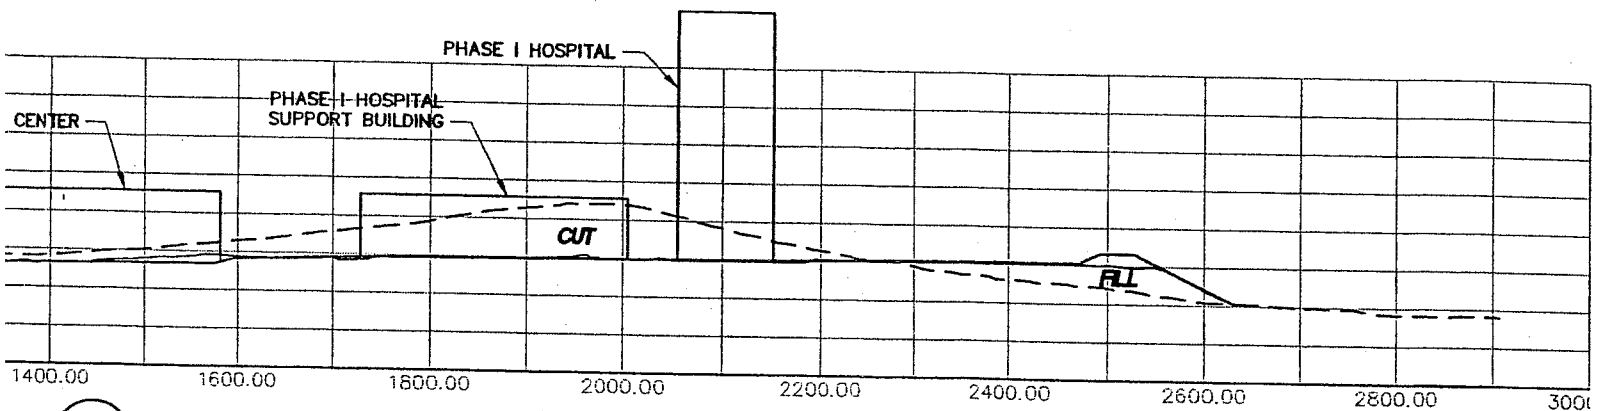
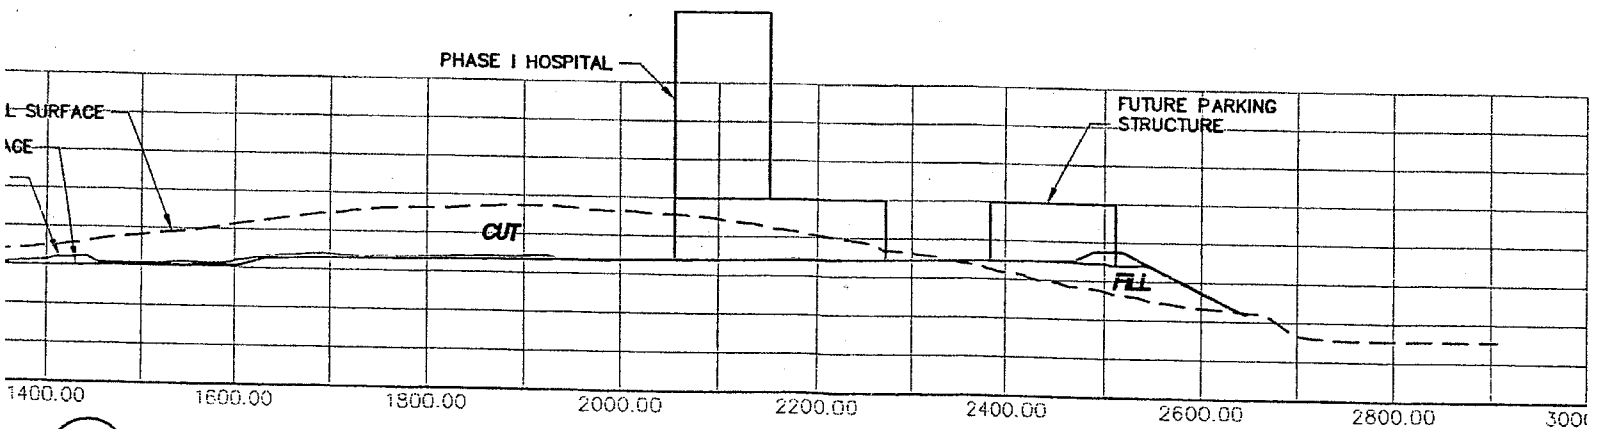
DATE	APP'D	SCALE:	PALOMAR MEDICAL CENTER WEST - ESCONDIDO, CA	
				DRAWN: D. Luong	NORTH-SOUTH CROSS-SECTIONS	
				CHECKED:	DRAWING NUMBER	
				DESIGNED:	Figure 4A	
				PROJ. MGR.		
				BILL GATES

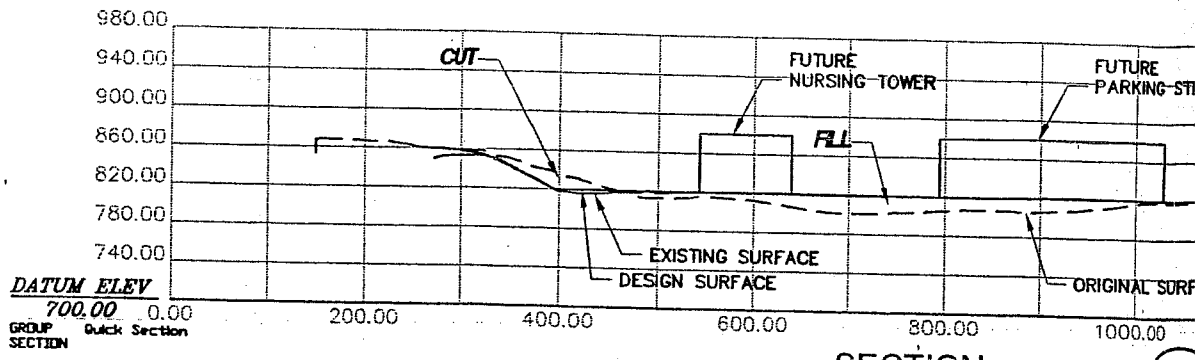
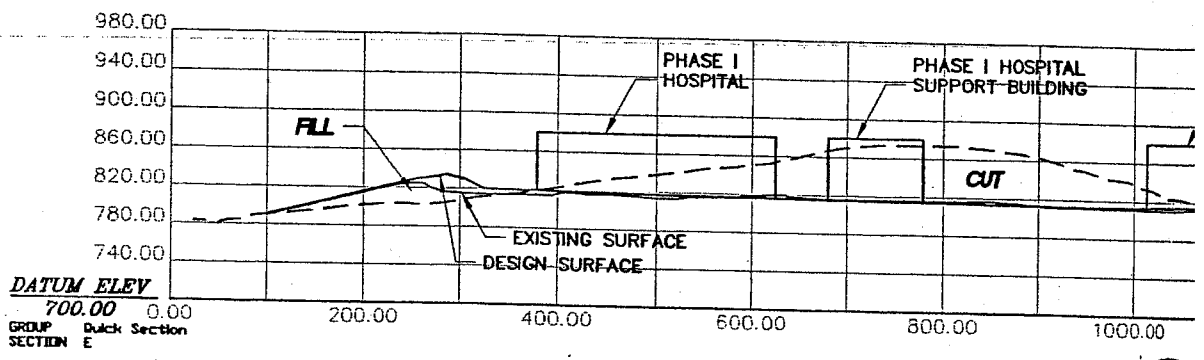
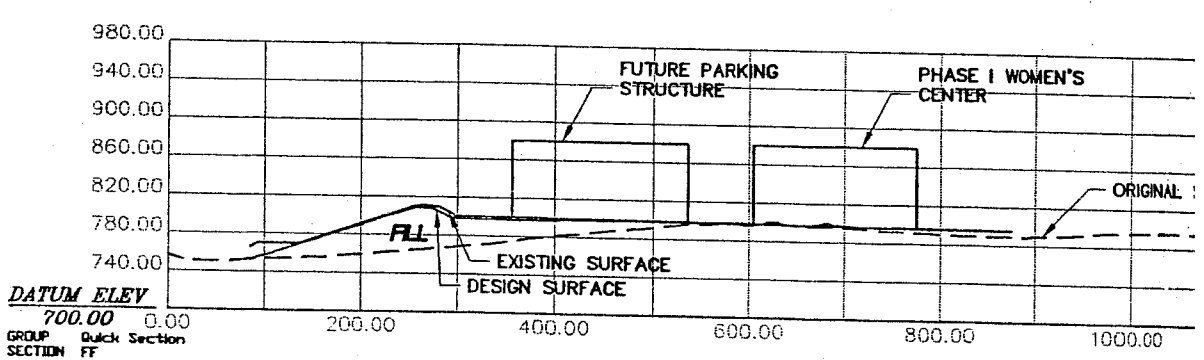
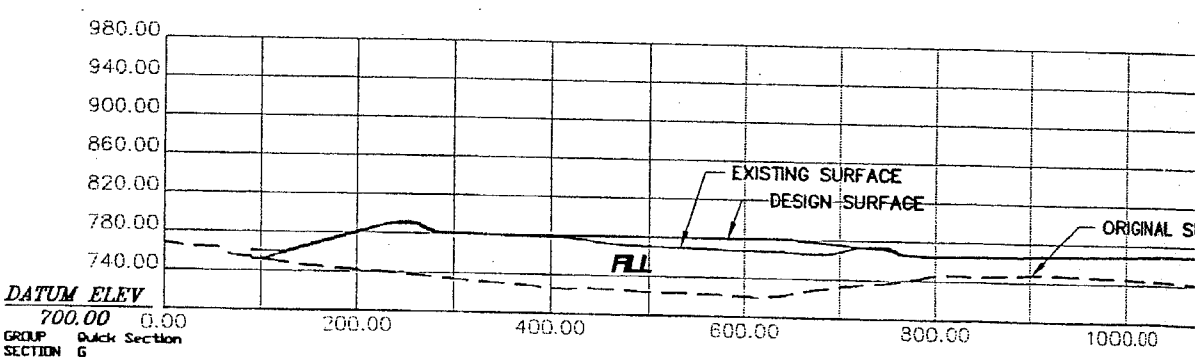
SECTION D
 SCALE: HORZ 1" = 100'
 VERT 1" = 10'

SECTION E
 SCALE: HORZ 1" = 100'
 VERT 1" = 10'

SECTION FF
 SCALE: HORZ 1" = 100'
 VERT 1" = 10'

SECTION G
 SCALE: HORZ 1" = 100'
 VERT 1" = 10'

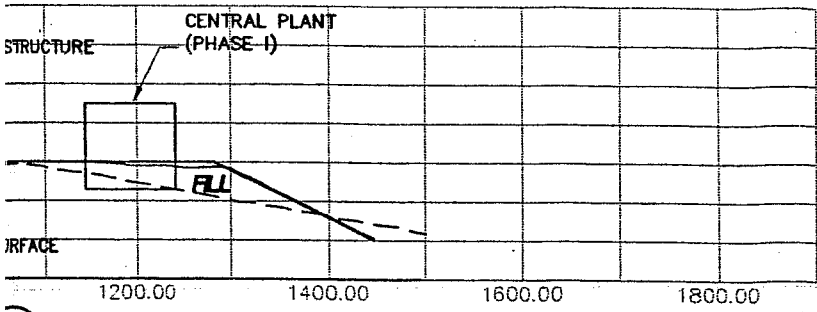
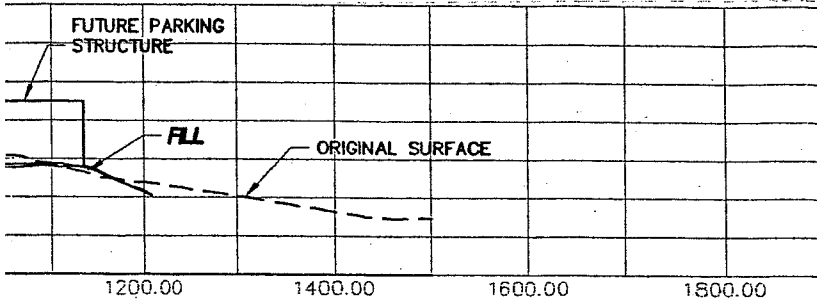
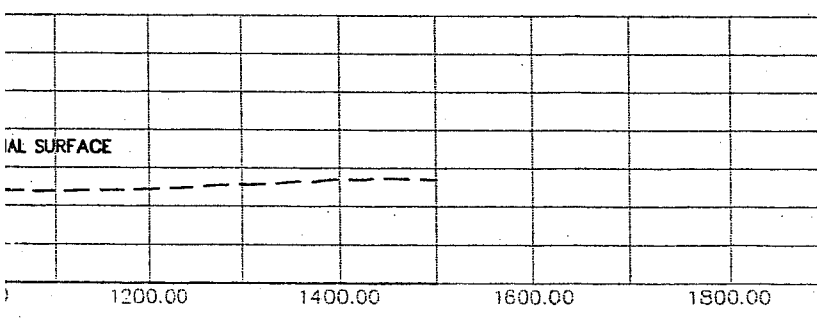
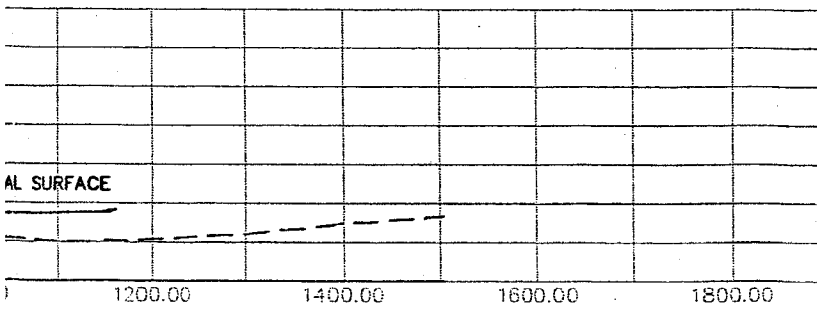
DRAWN: D. Luong		
			CHECKED:		
			DESIGNED:		
			PROJ. MGR.	DRAWING NUMBER	
			BILL GATES	Figure 4B

DATE		APP'D	SCALE	PALOMAR MEDICAL CENTER WEST - ESCONDIDO, CA	
				EAST-WEST CROSS-SECTIONS

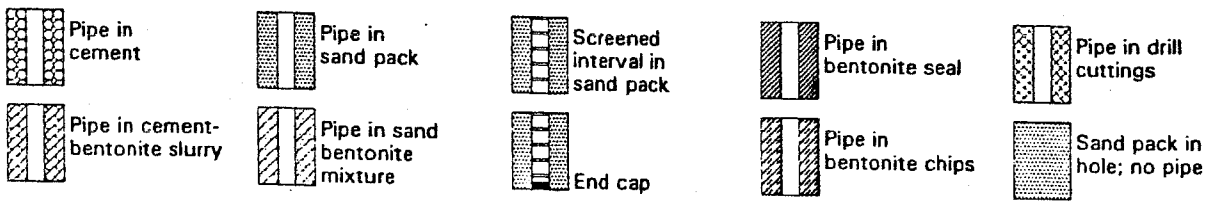
- 13 Incliner Casing Log:** Graphic depiction of casing installation; symbols explained below.
